**PHASE I
ENVIRONMENTAL SITE ASSESSMENT
MARION STREET HIGHRISE
1930 MARION STREET
COLUMBIA, RICHLAND COUNTY, SOUTH CAROLINA**

**D3G PROJECT NUMBER:
2020 - 0581**

**FINAL REPORT ISSUE DATE:
JULY 23, 2020**

**INSPECTION DATE:
JANUARY 14, 2020**

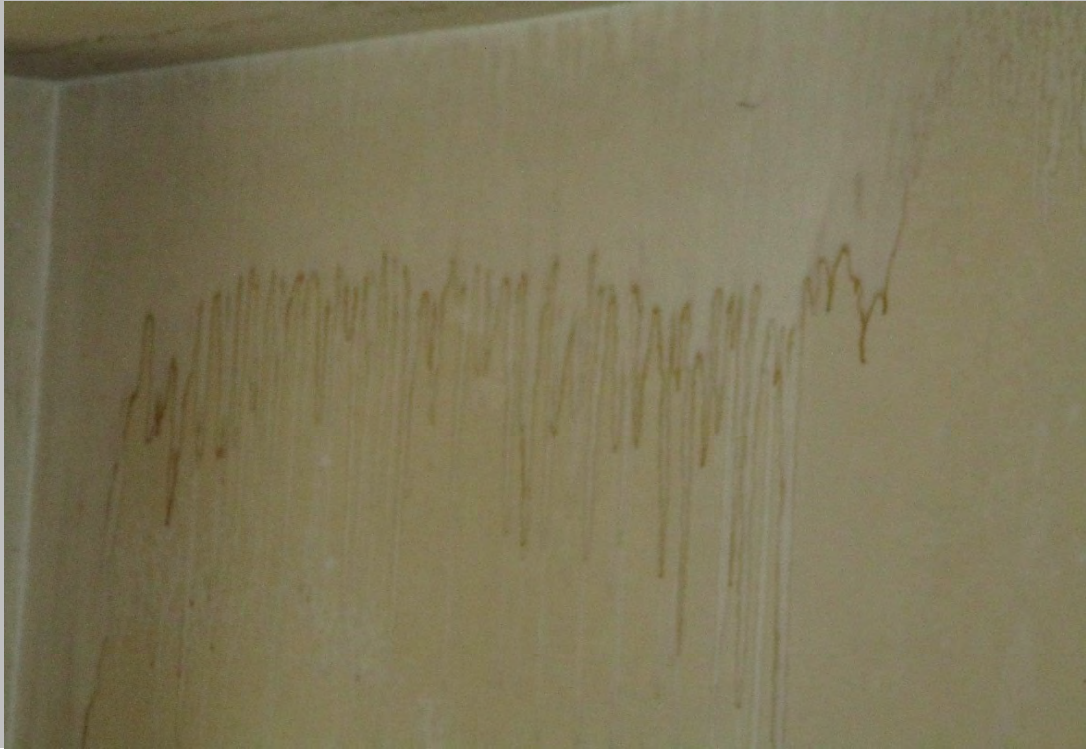
PHOTO #13

The subject property was visually inspected for the presence of mold growth during the site investigation. During the site visit on January 14, 2020 evidence of moisture intrusion and/or mold was observed throughout the structure as a result of the frequent plumbing leaks and exterior water infiltration. An inspection of exterior areas of the property did not identify evidence of standing water, or improper site drainage characteristics.

View of typical moisture intrusion in Unit 2E

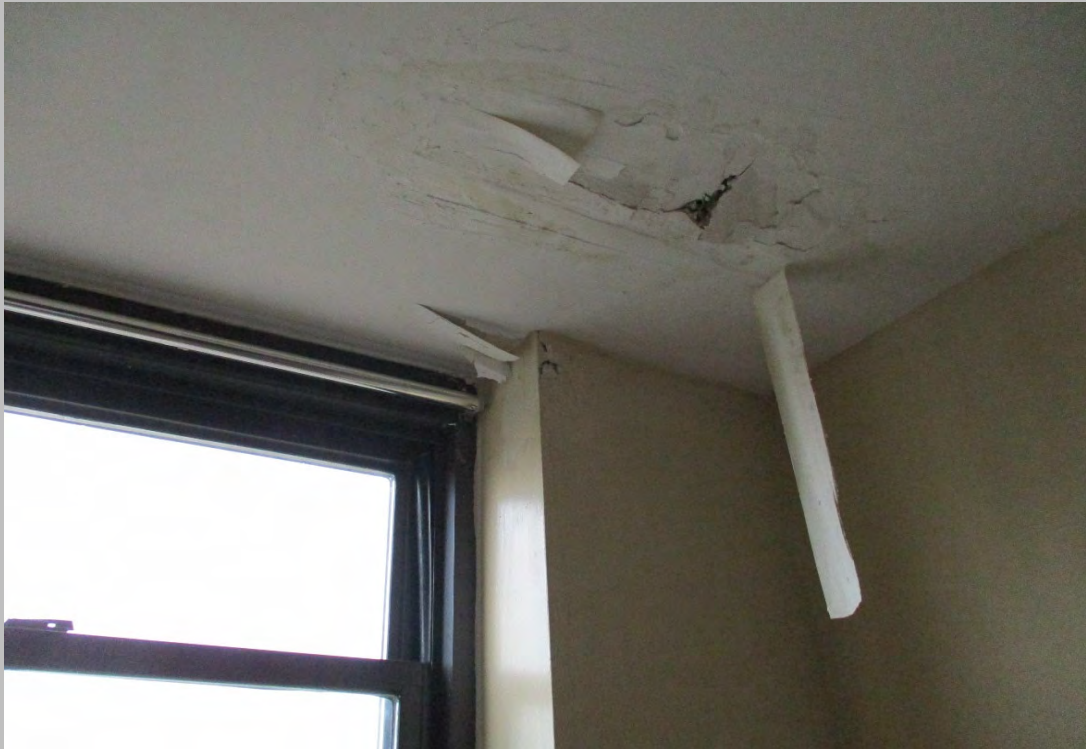
PHOTO #14

View of typical moisture intrusion in Unit 10F

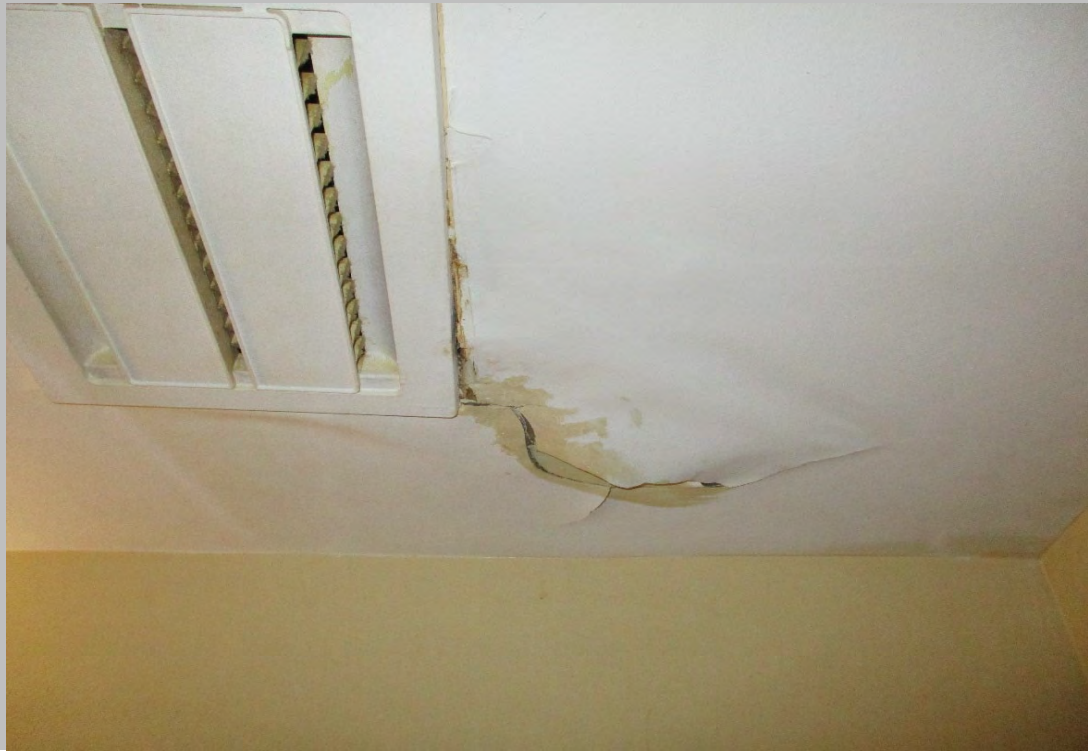
PHOTO #15

View of typical moisture intrusion in Unit 8E

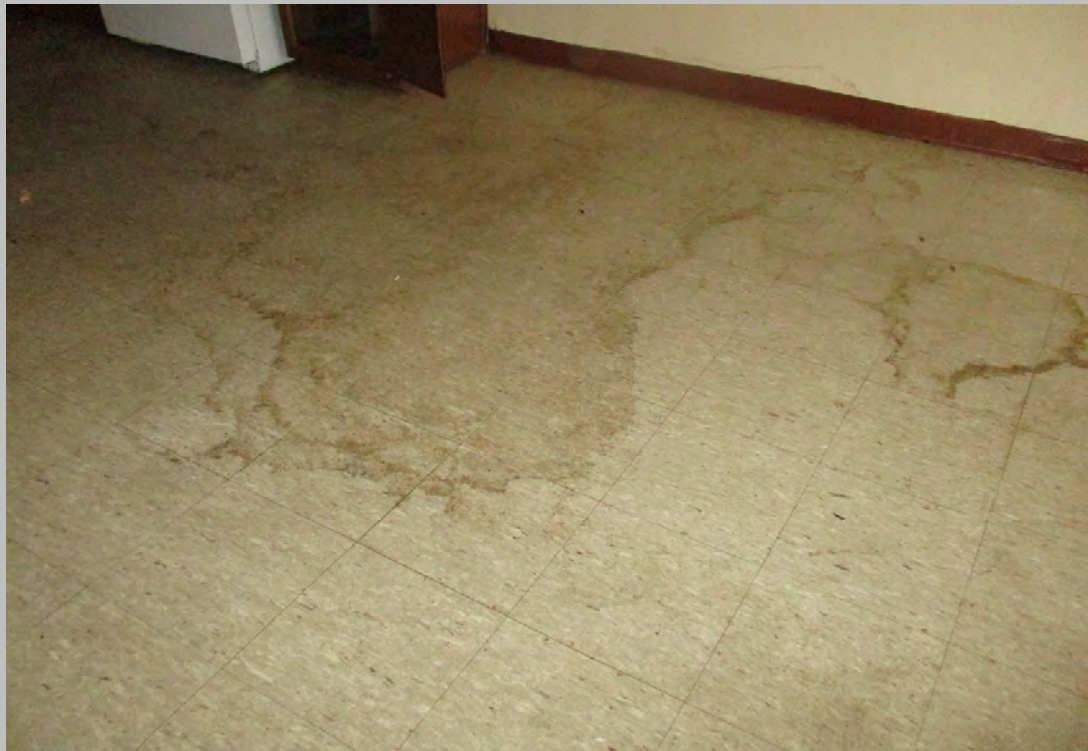
PHOTO #16

View of typical moisture intrusion in Unit 11F

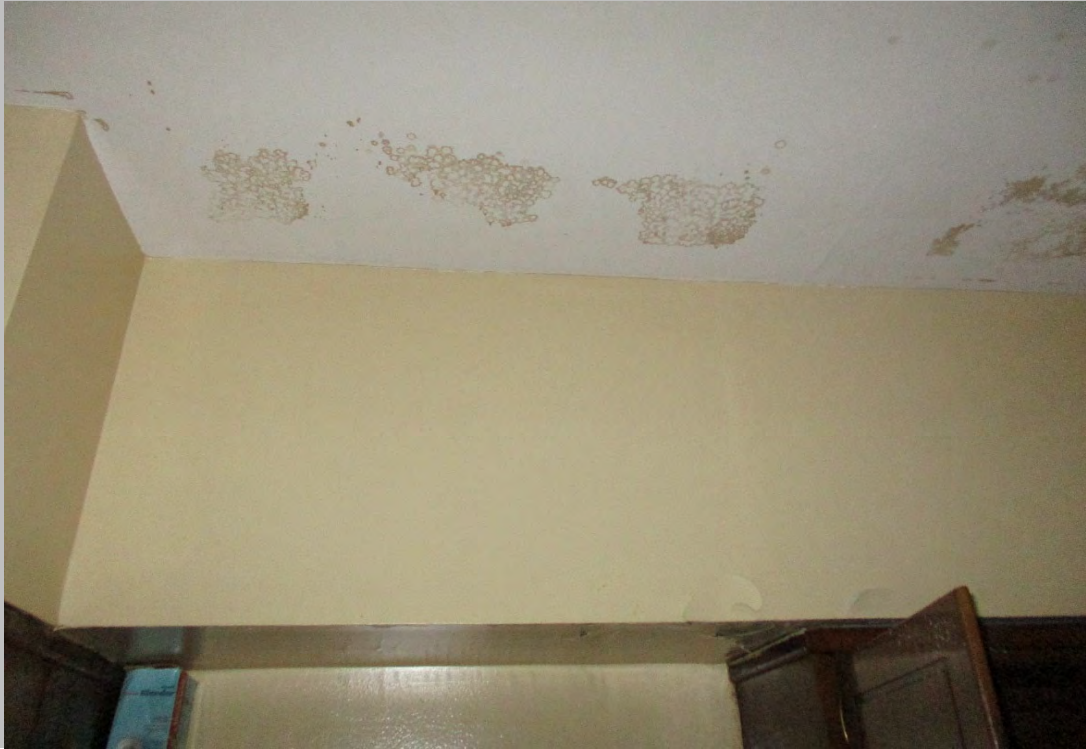
PHOTO #17

View of typical moisture intrusion in Unit 4E

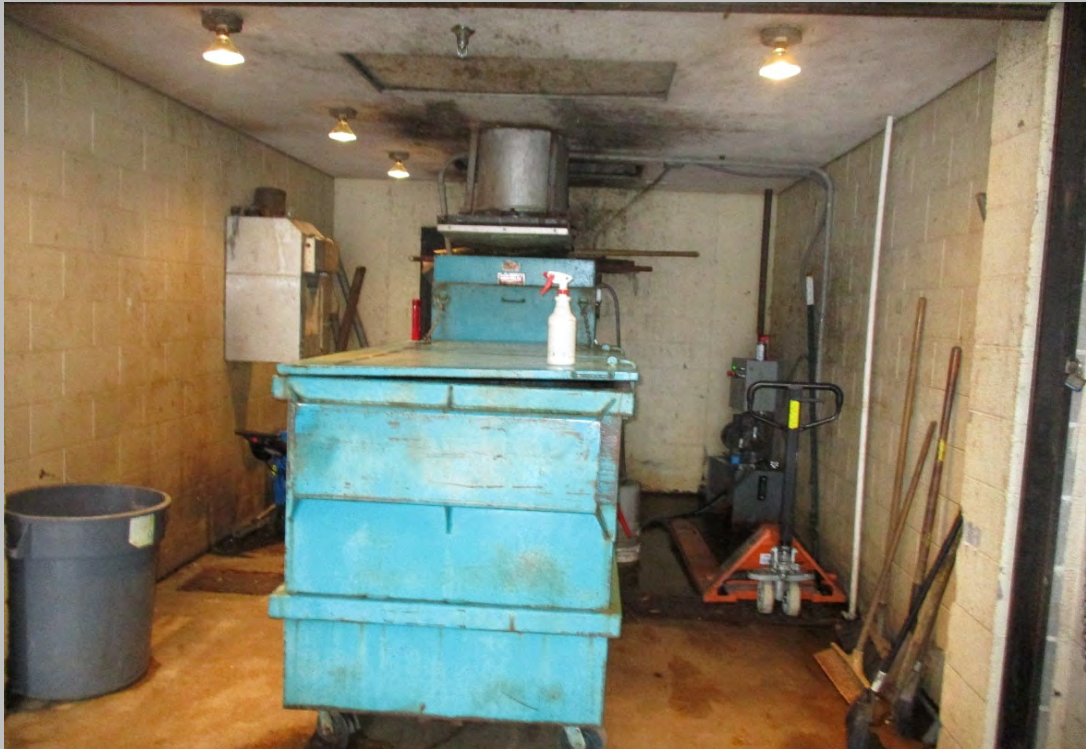
PHOTO #18

(2) One (1) hydraulic trash compactor is located at the subject property. It is not known whether the hydraulic trash compactor oil contains regulated levels of PCBs. In addition, leakage was not observed at the time of the subject property visit. Therefore, the trash compactor is not believed to present environmental concerns to the subject property.

View of the hydraulic trash compactor

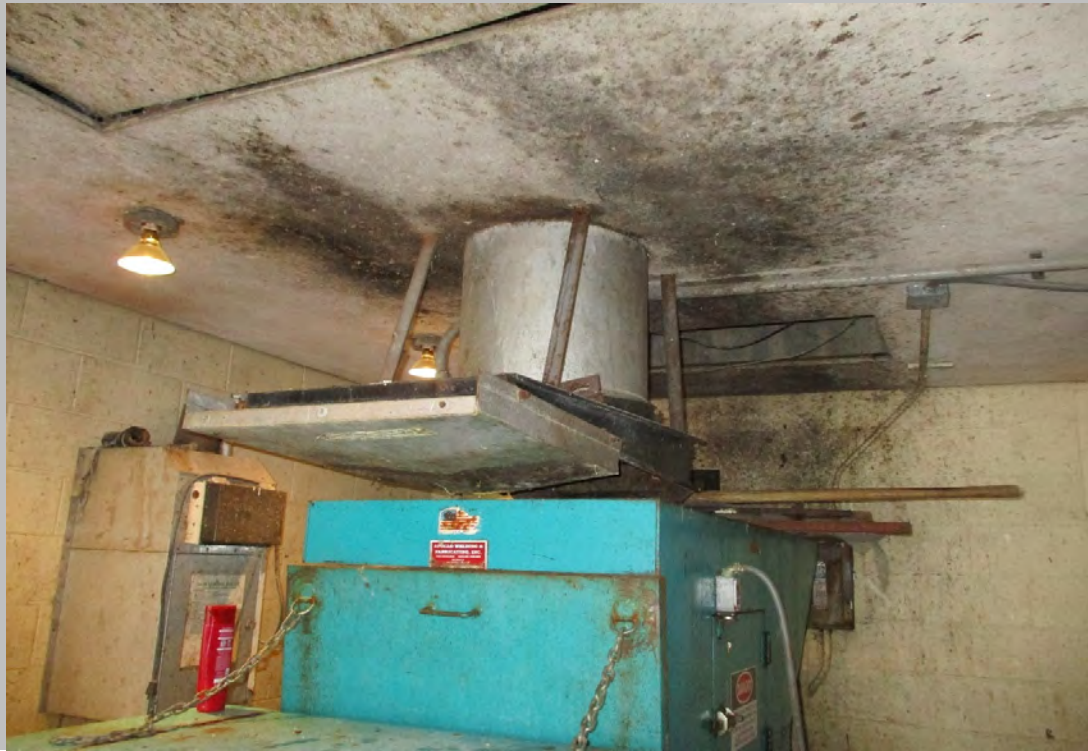
PHOTO #19

View of the mold near the hydraulic trash compactor
