REQUEST FOR PROPOSALS

MARION STREET HIGHRISE

Property: Marion Street High Rise
1930 Marion Street
Columbia, South Carolina 29201

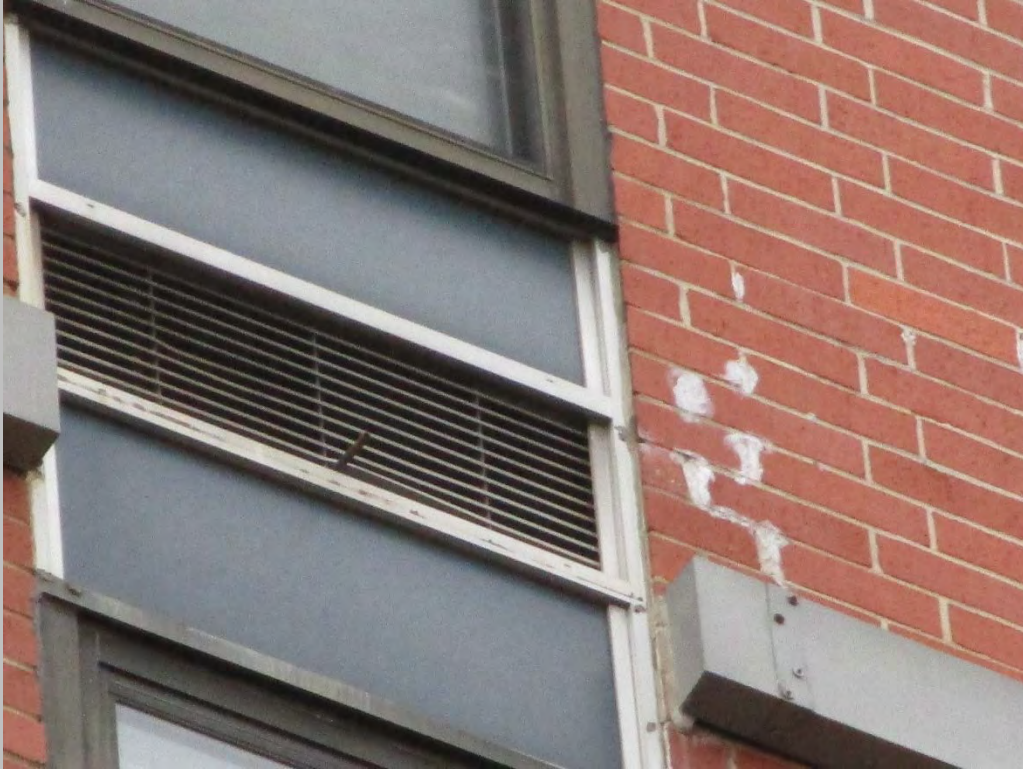
PHOTO #5

Significant cracking of the brick façade throughout

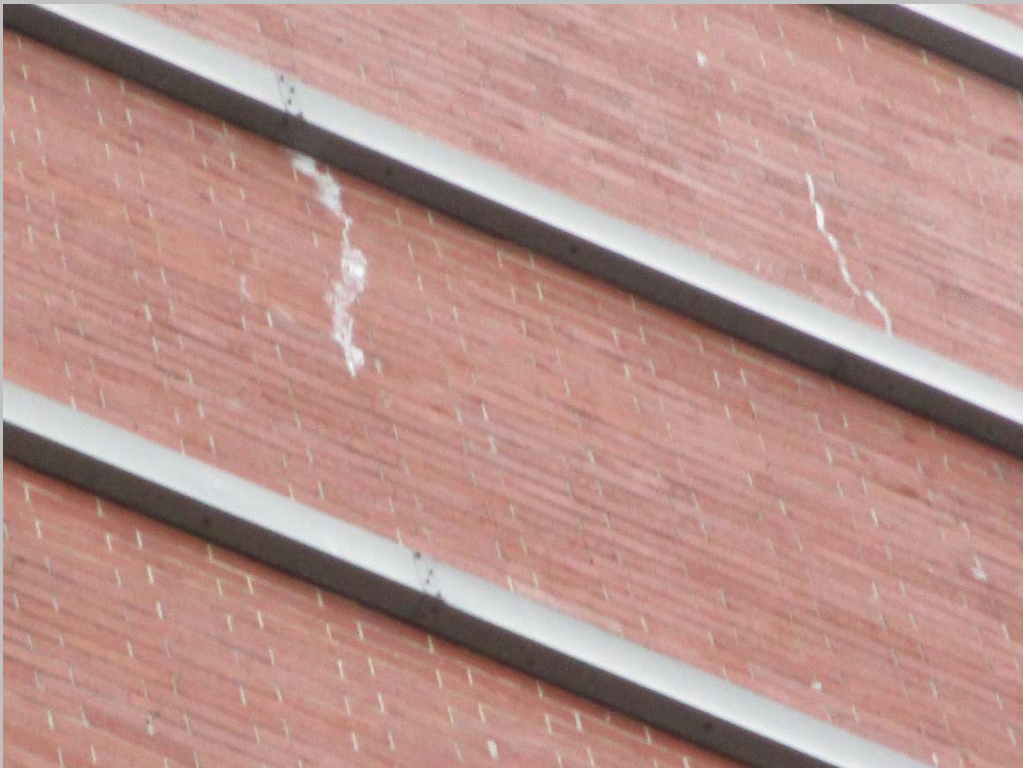
PHOTO #6

Significant cracking of the brick façade throughout

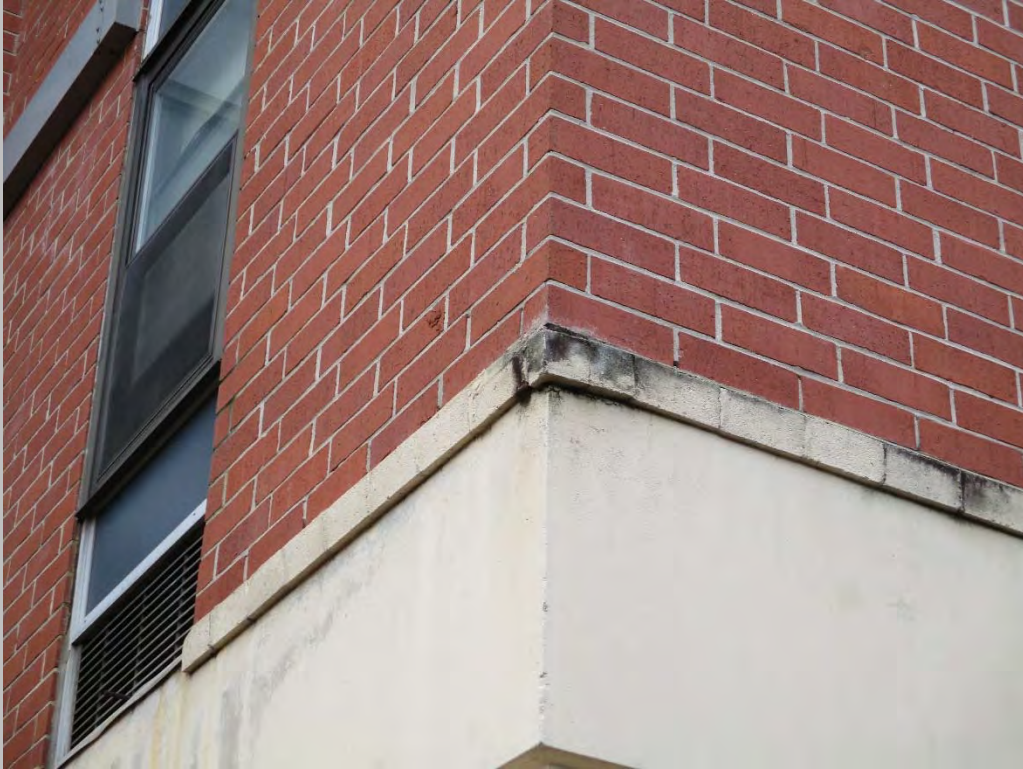
PHOTO #7

Significant cracking of the brick façade throughout

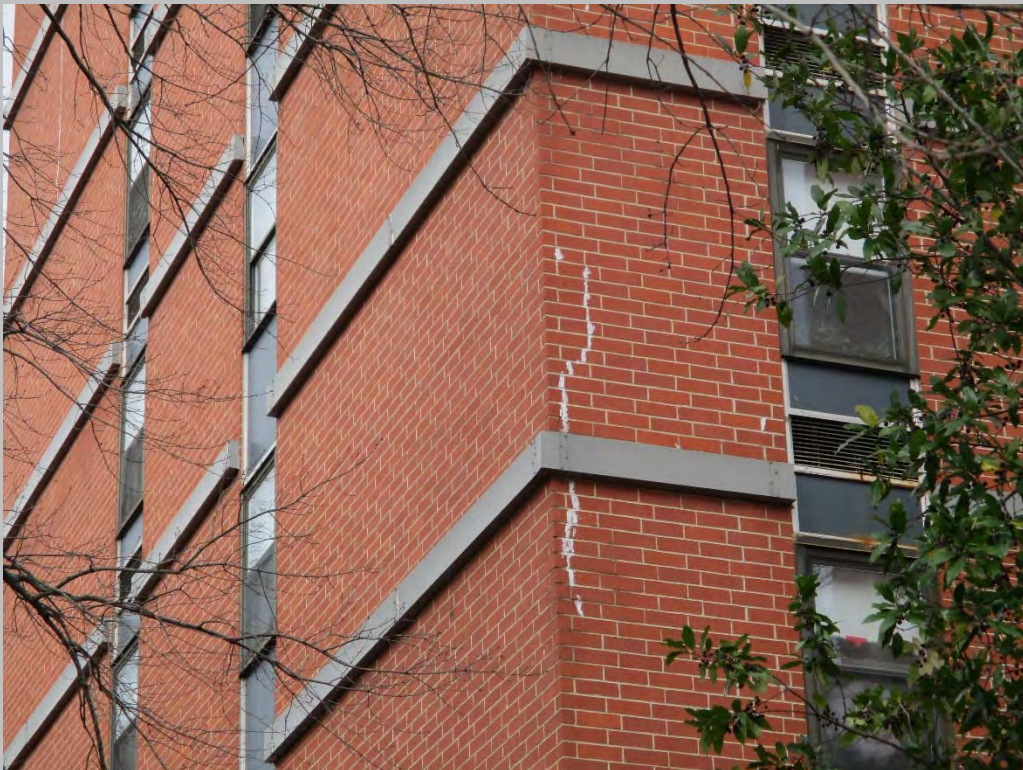
PHOTO #8

Significant cracking of the brick façade throughout

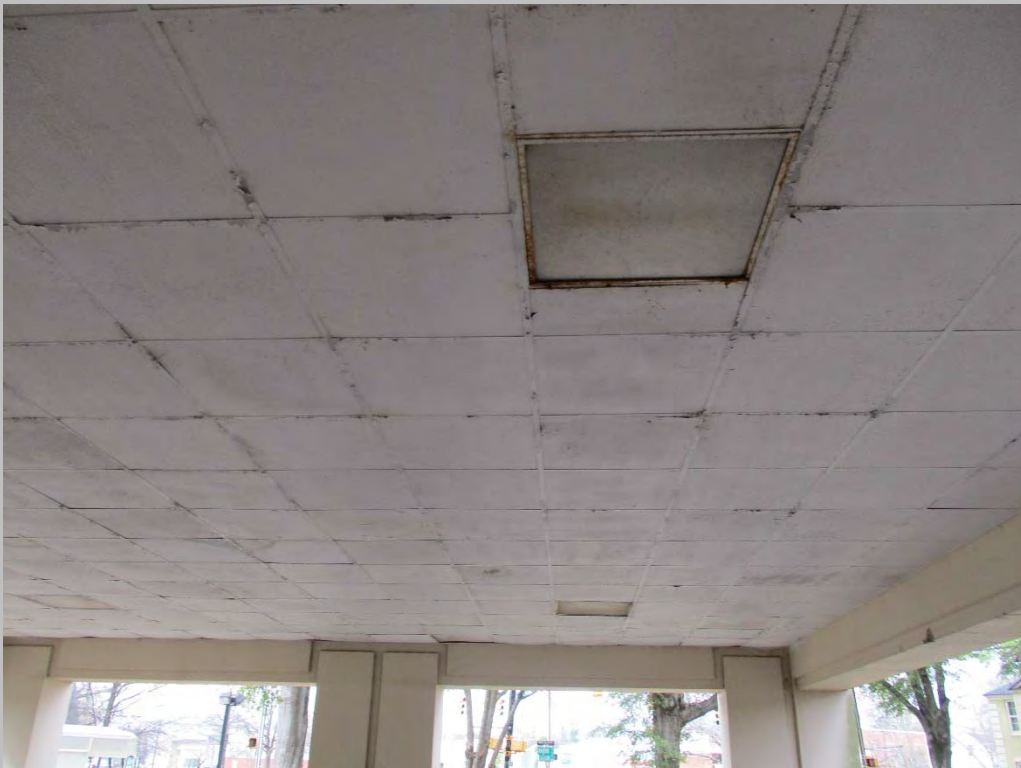
PHOTO #10

Porte cochere ceiling in poor condition

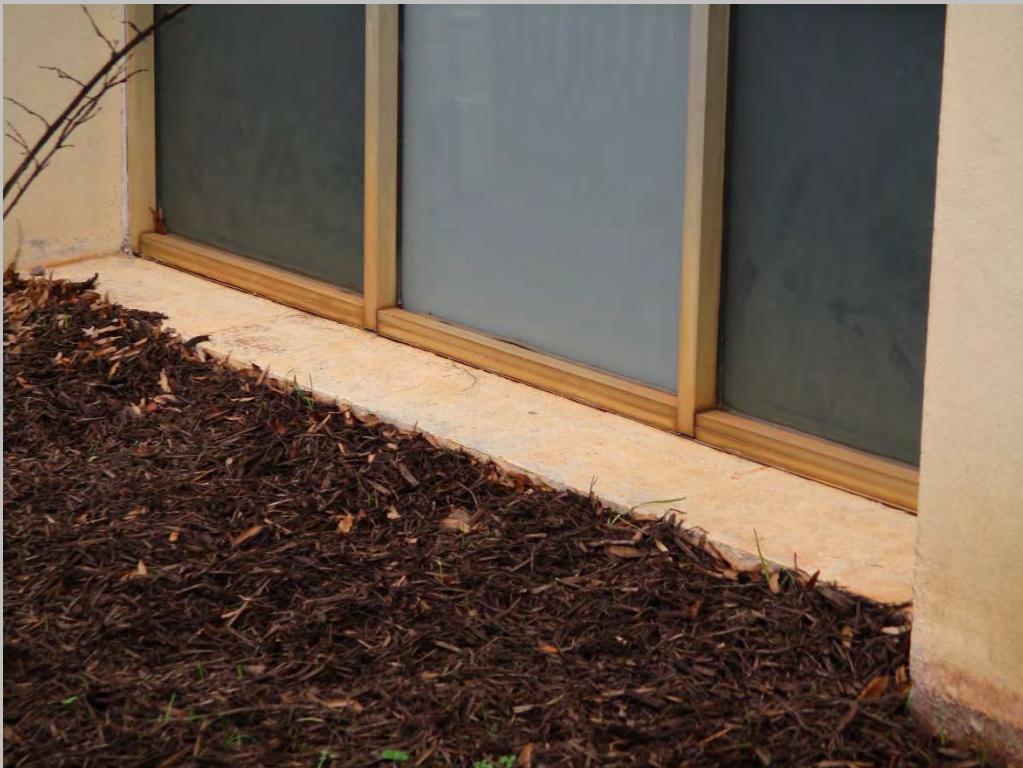
PHOTO #14

Failing sealants at all glass storefront window assemblies

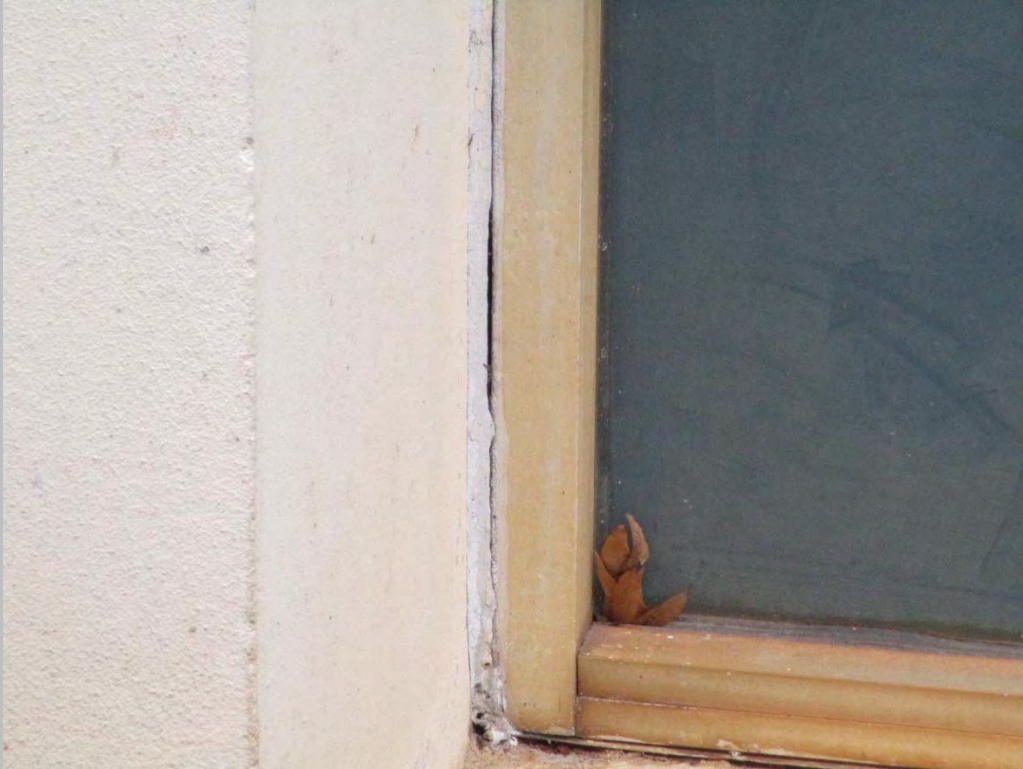
PHOTO #15

Failing sealants at all glass storefront window assemblies

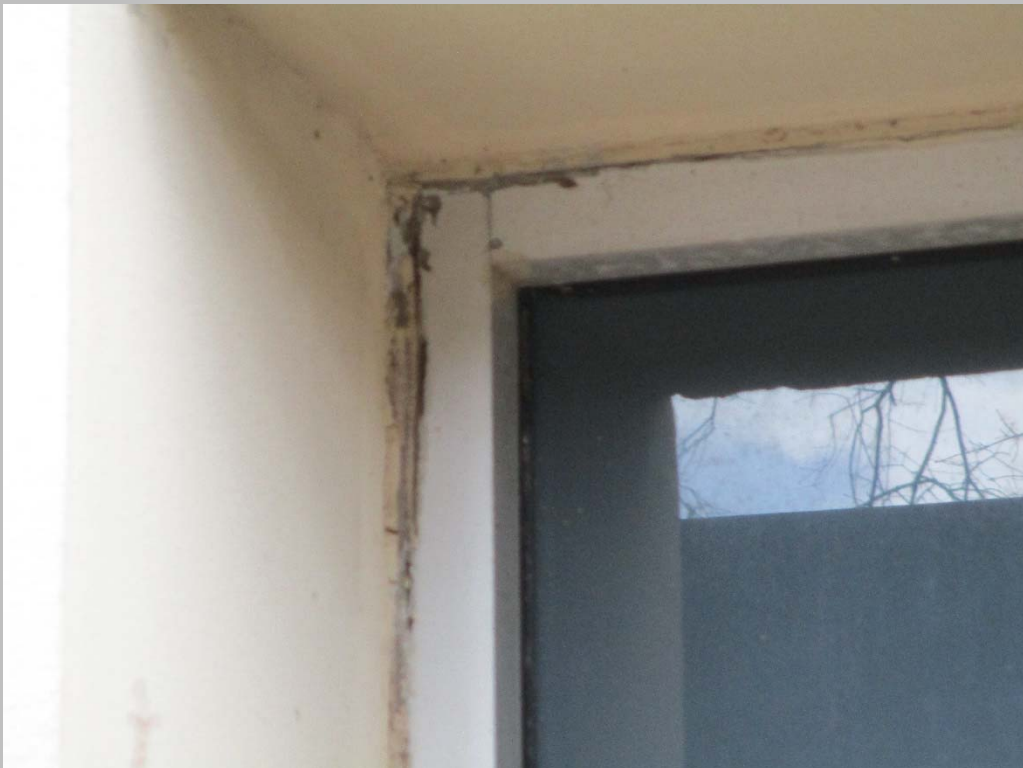
PHOTO #16

Failing sealants at all glass storefront window assemblies

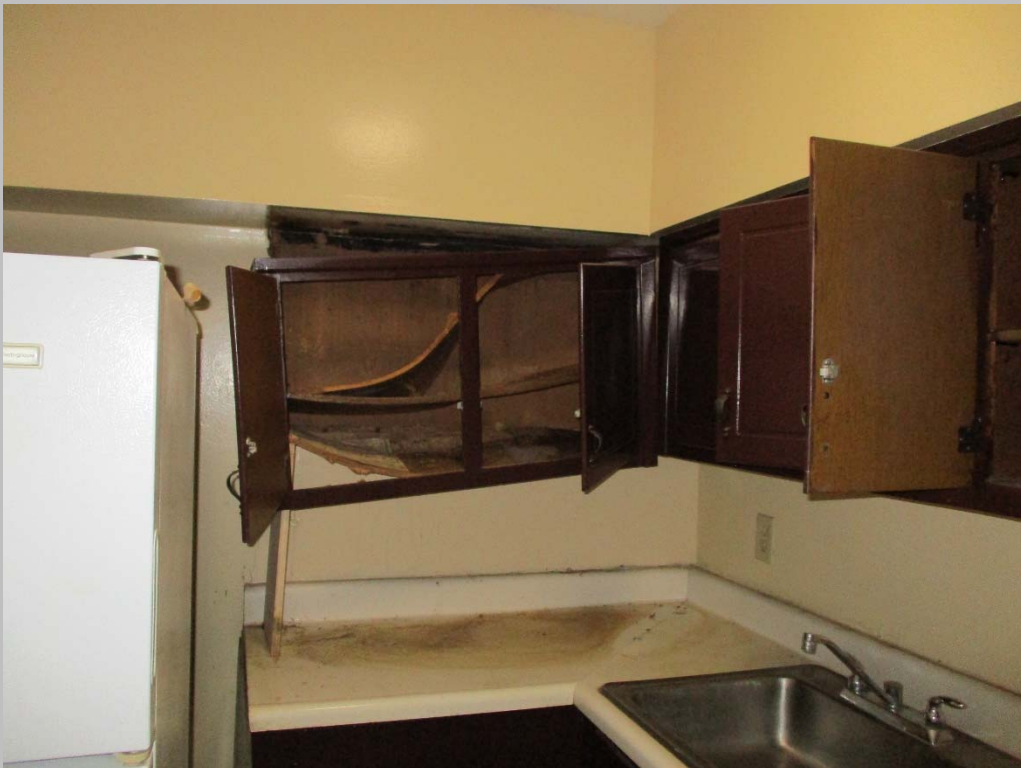
PHOTO #32

Typical dwelling unit kitchen cabinetry with water damage

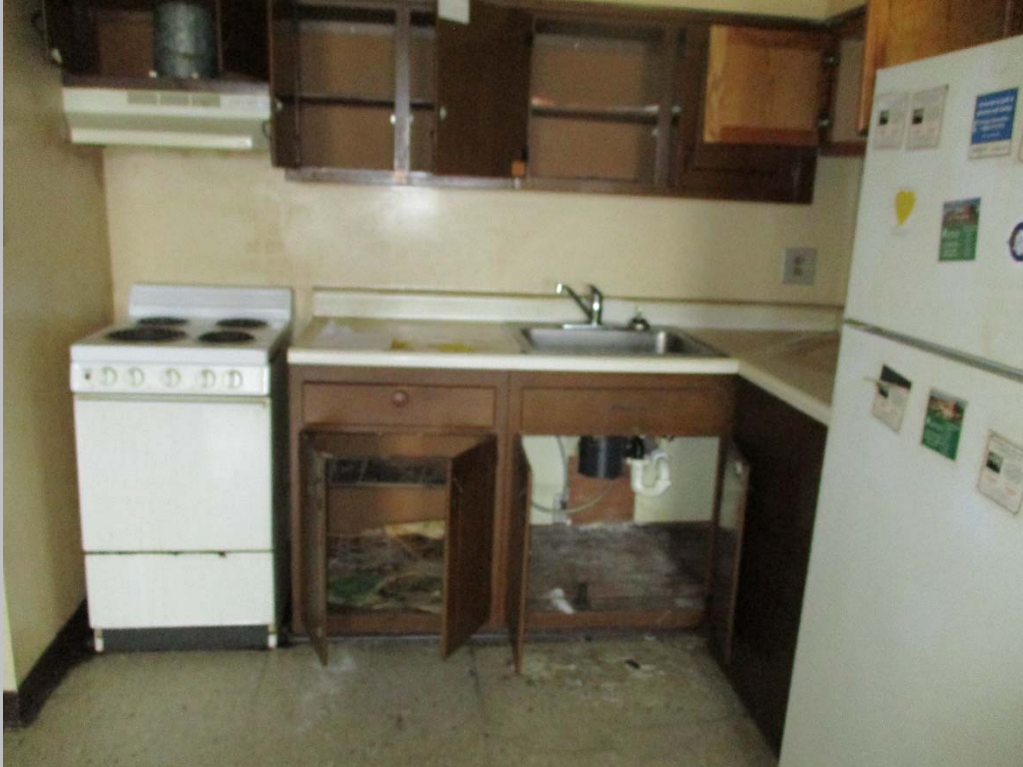
PHOTO #33

Typical dwelling unit kitchen cabinetry with water damage

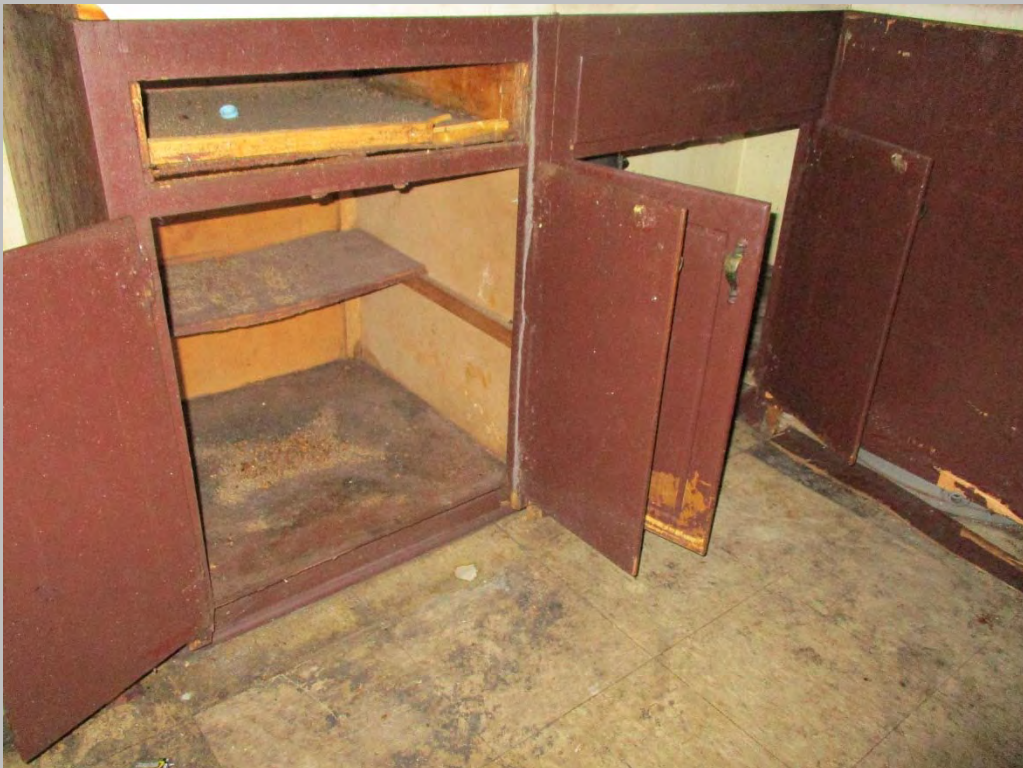
PHOTO #34

Typical dwelling unit kitchen cabinetry with water damage

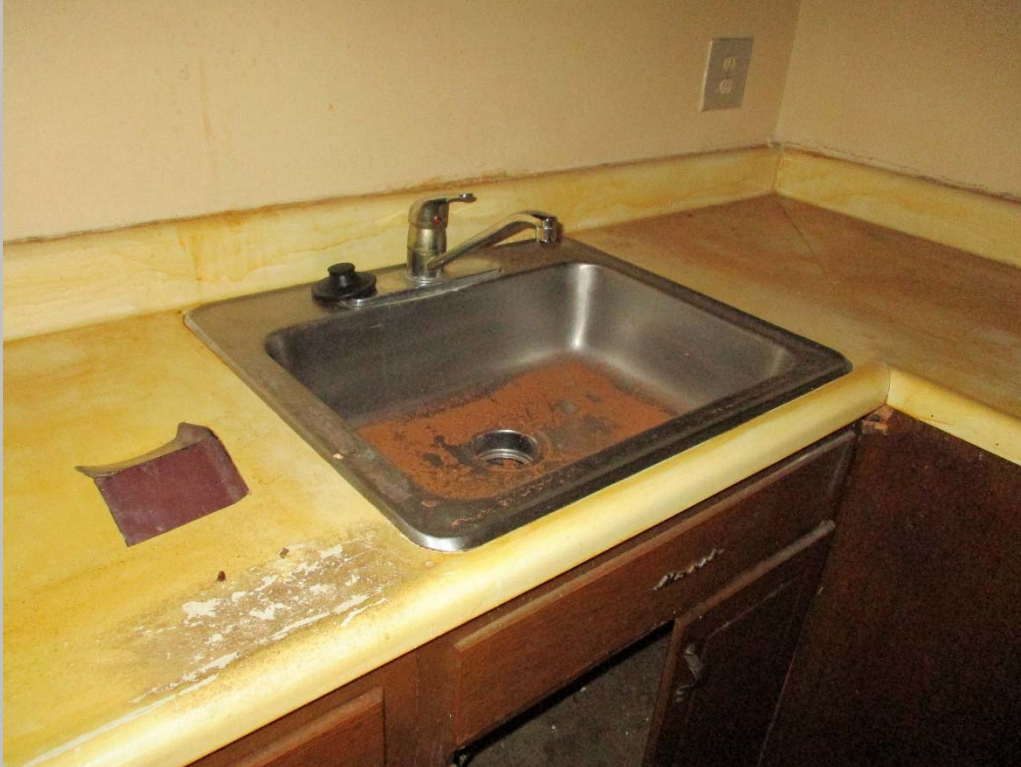
PHOTO #35

Typical dwelling unit kitchen cabinetry with water damage

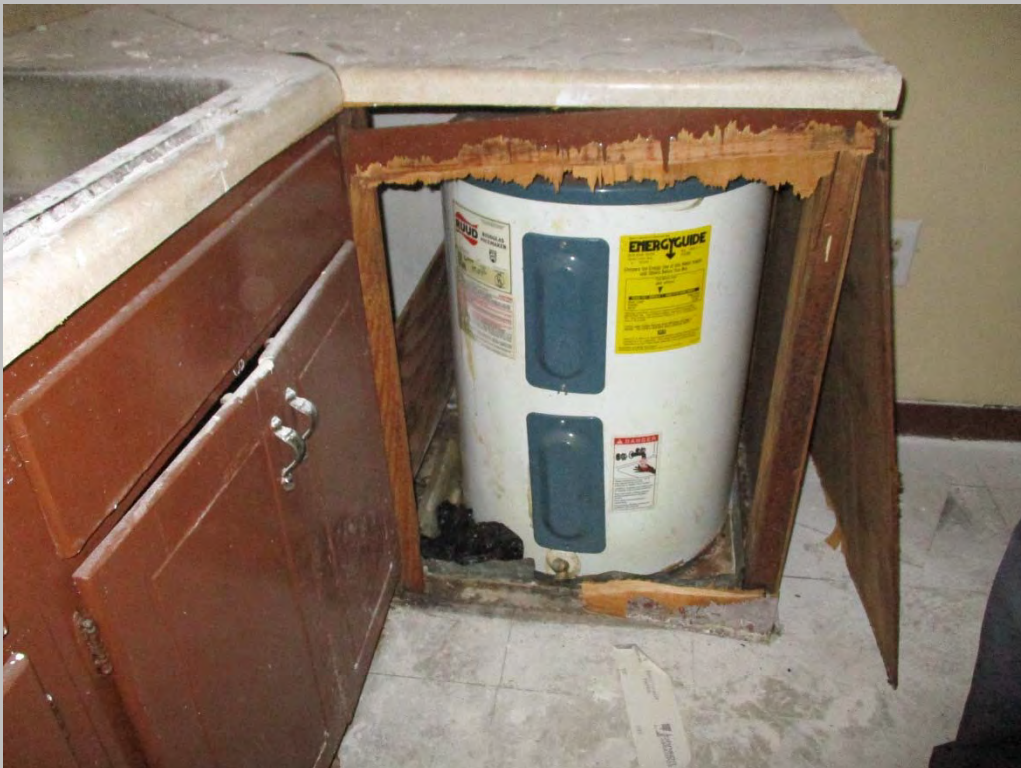
PHOTO #36

Typical dwelling unit kitchen cabinetry with water damage

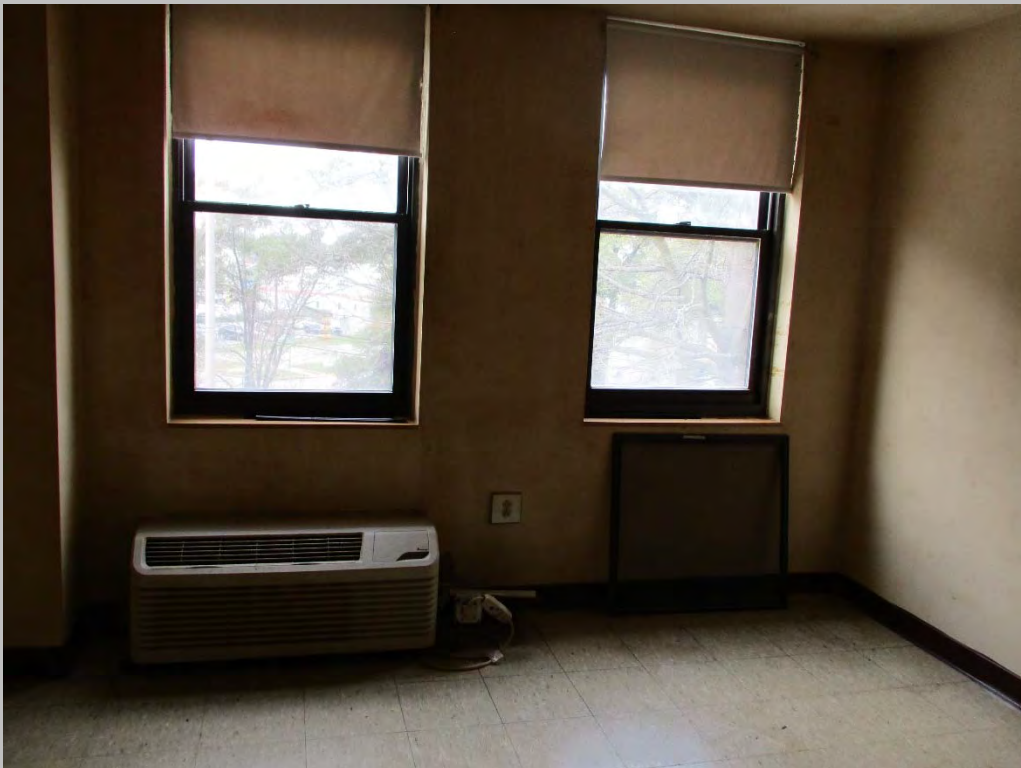
PHOTO #38

Water damaged VCT flooring throughout

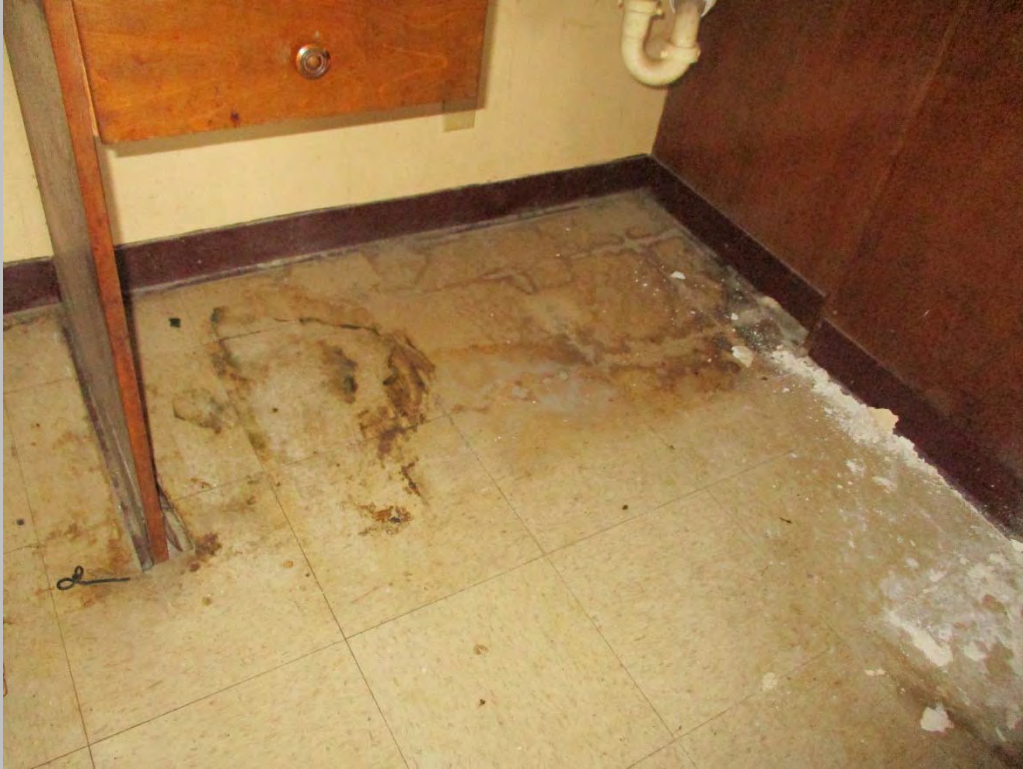
PHOTO #39

Water damaged VCT flooring throughout

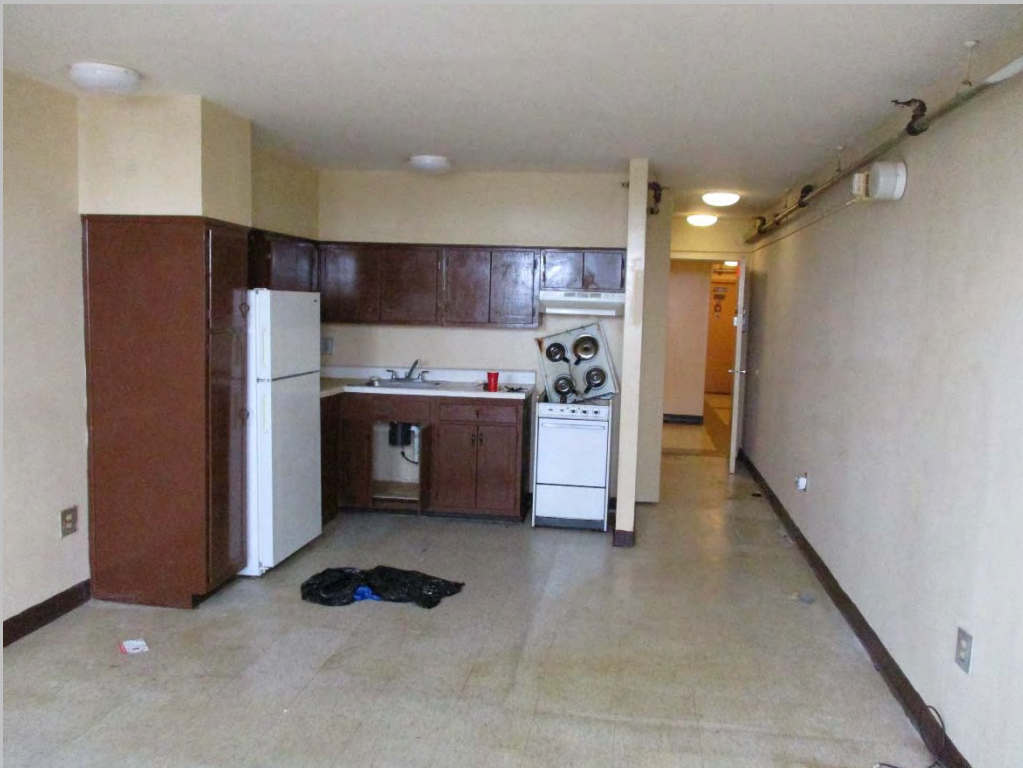
PHOTO #40

Water damaged VCT flooring throughout

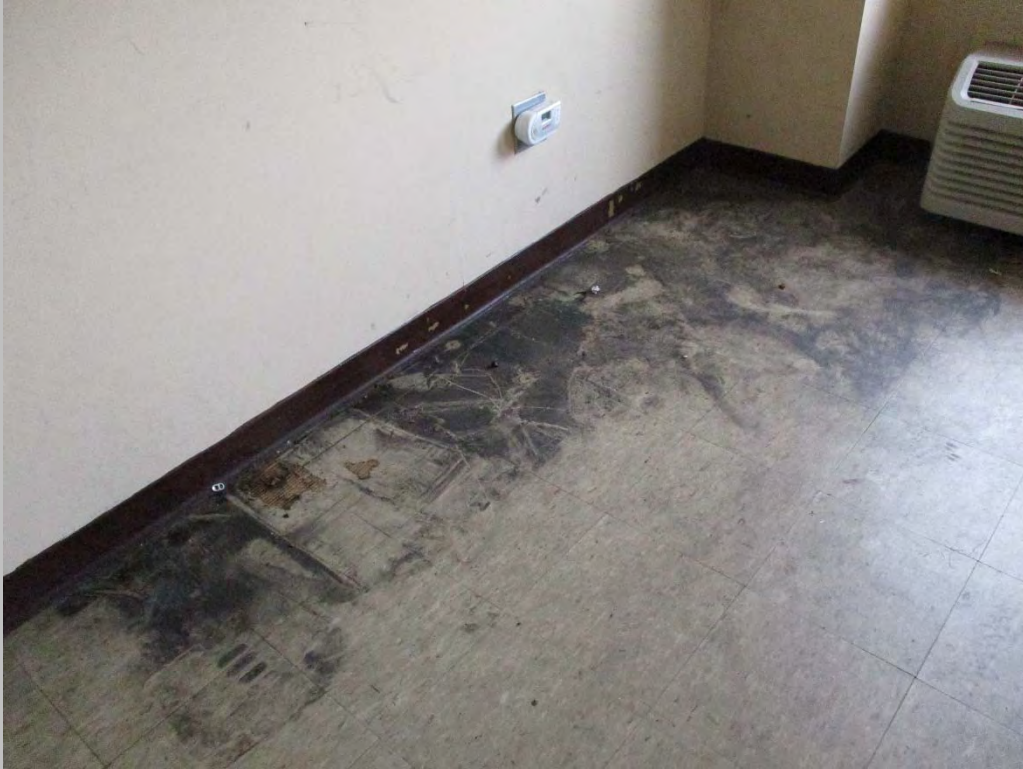
PHOTO #41

Water damaged VCT flooring throughout

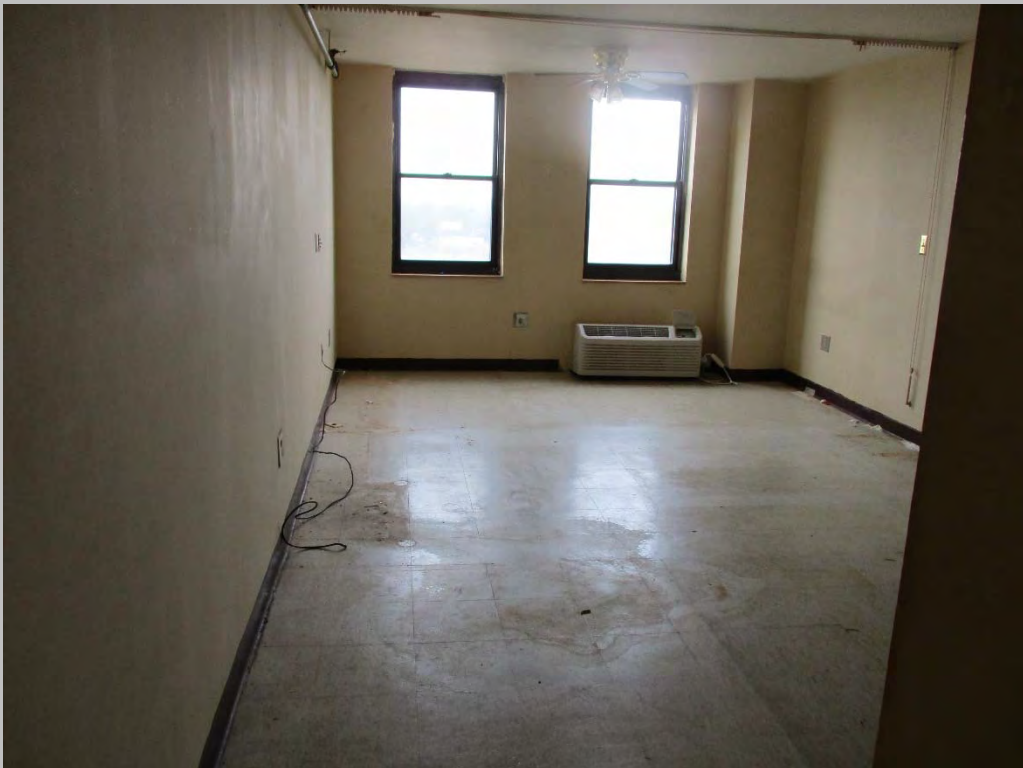
PHOTO #42

Water damaged VCT flooring throughout

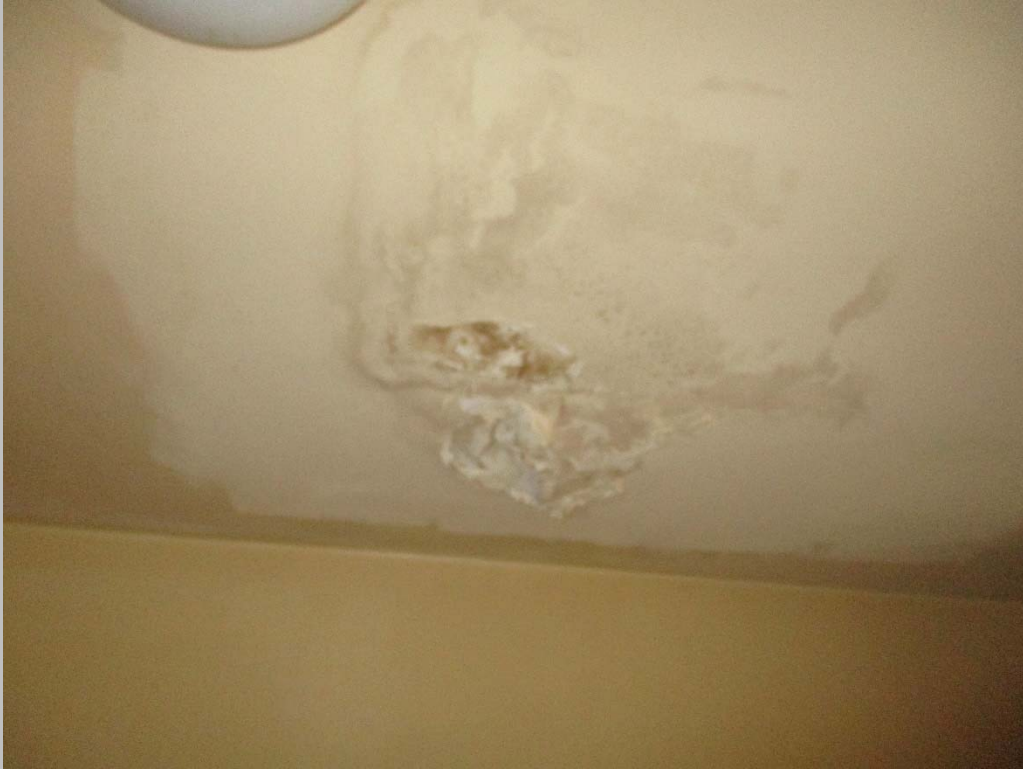
PHOTO #43

Water damaged ceilings throughout

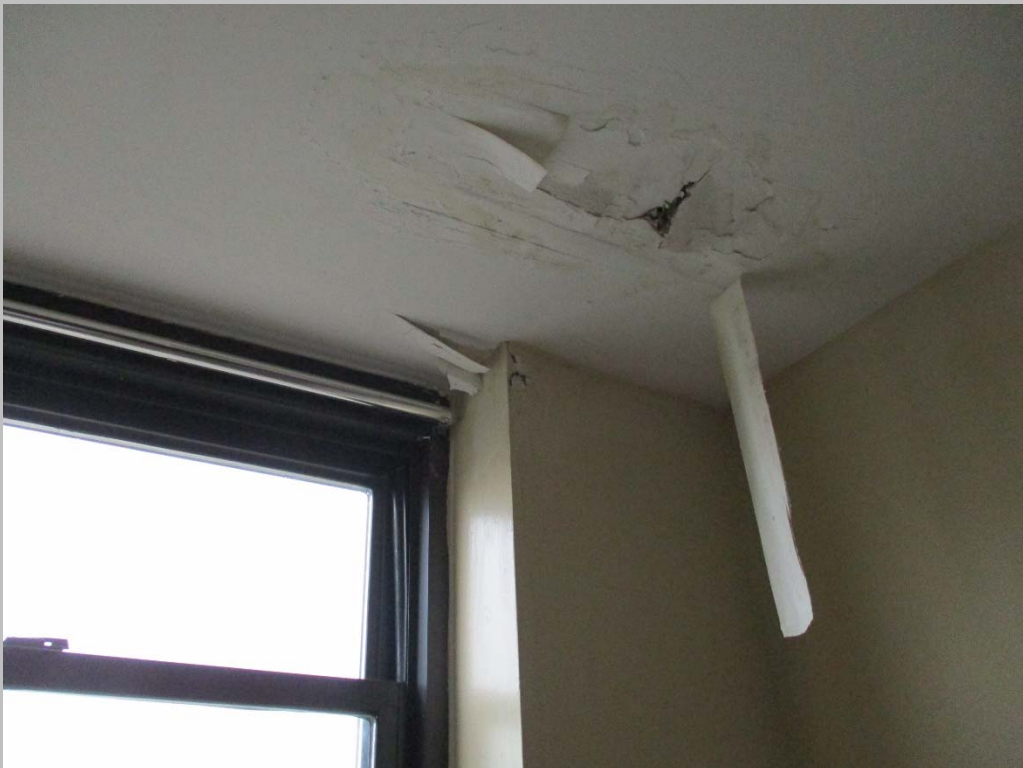
PHOTO #44

Water damaged ceilings throughout

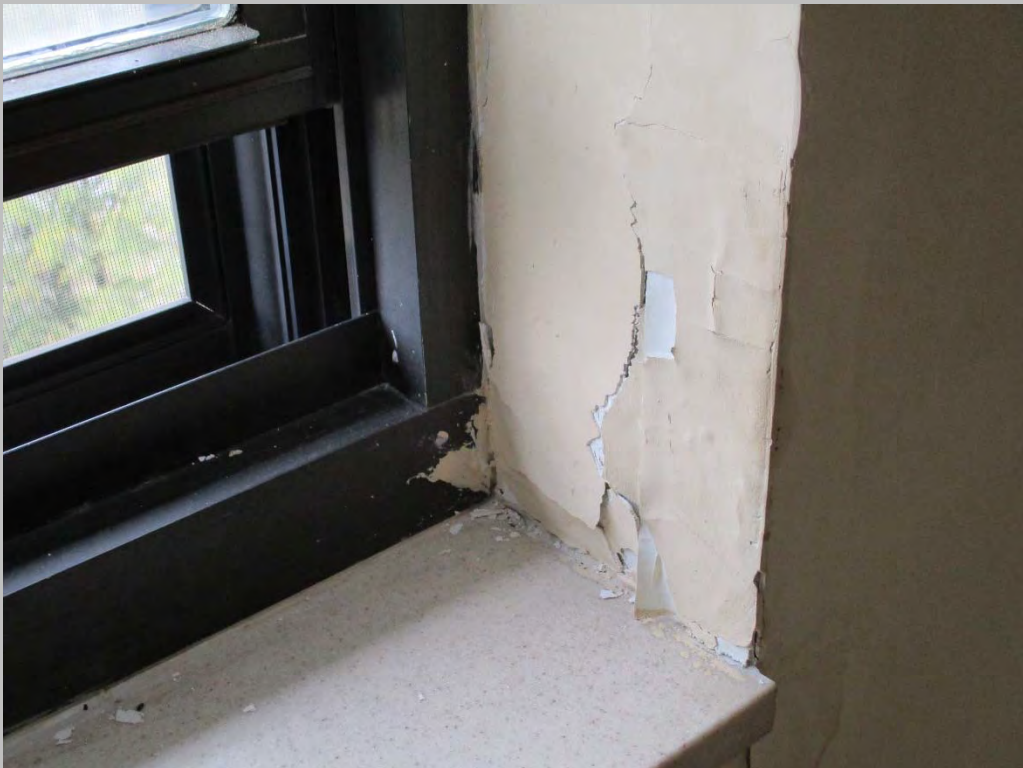
PHOTO #46

Wall damage due to exterior water infiltration throughout

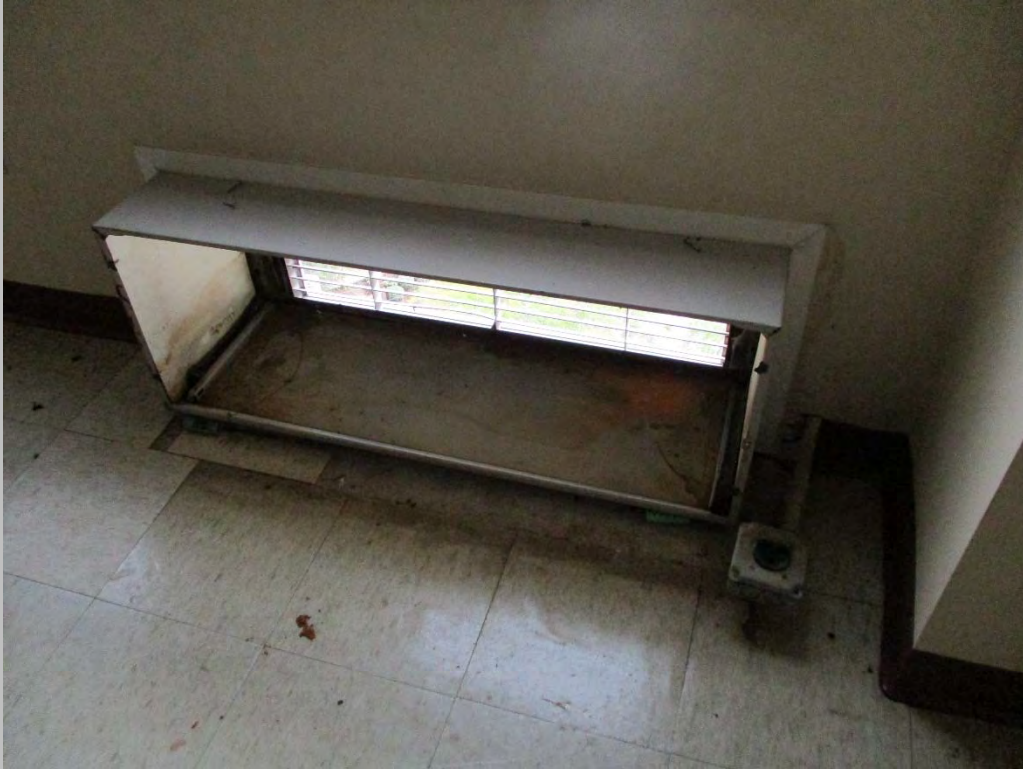
PHOTO #47

Flooring damage due to exterior water infiltration throughout
