**PHASE I
ENVIRONMENTAL SITE ASSESSMENT
MARION STREET HIGHRISE
1930 MARION STREET
COLUMBIA, RICHLAND COUNTY, SOUTH CAROLINA**

**D3G PROJECT NUMBER:
2020 - 0581**

**FINAL REPORT ISSUE DATE:
JULY 23, 2020**

**INSPECTION DATE:
JANUARY 14, 2020**

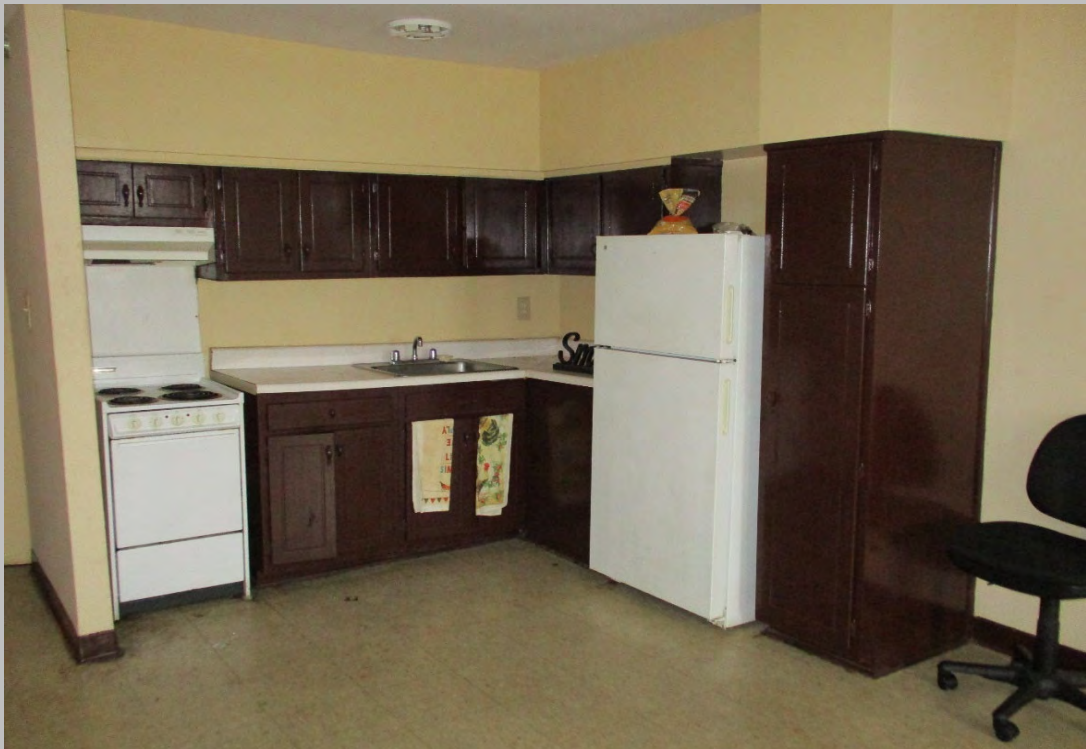
PHOTO #6

View of a typical residential unit kitchen

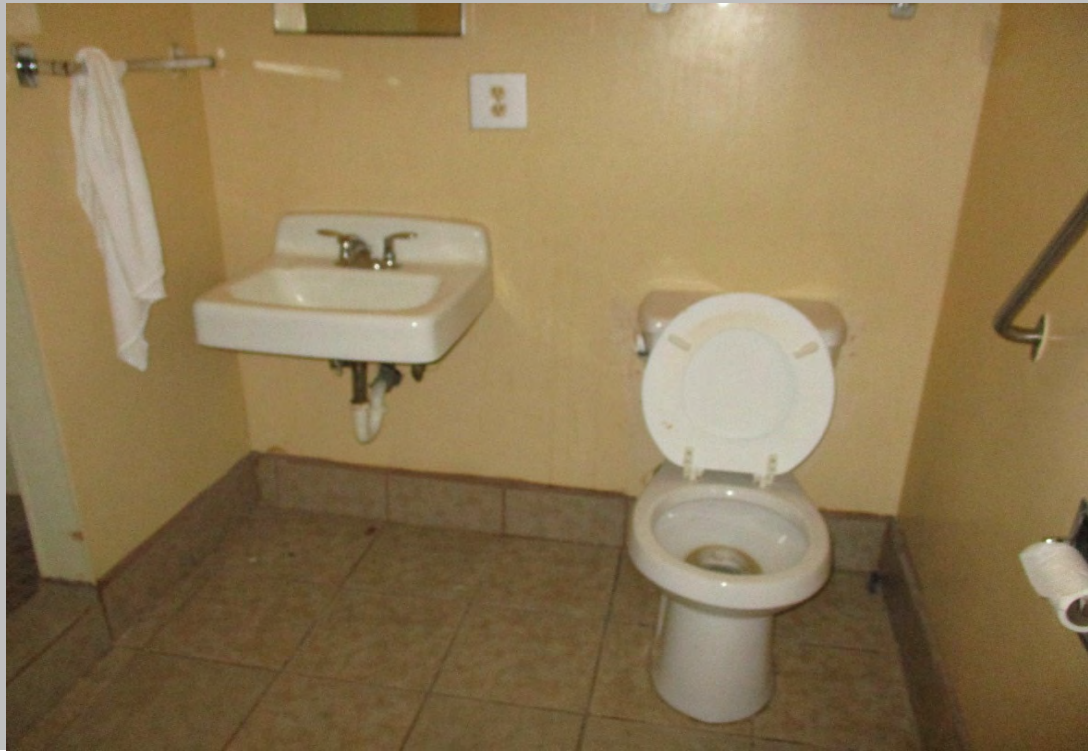
PHOTO #7

View of a typical residential unit bathroom

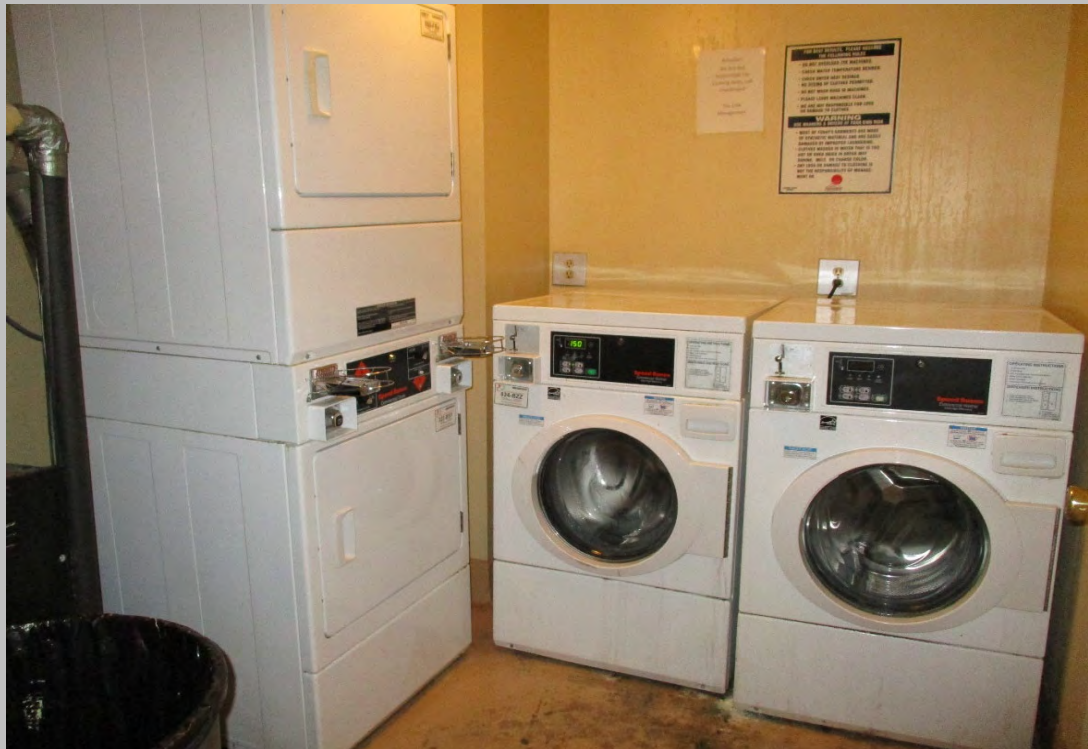
PHOTO #10

View of the laundry facilities

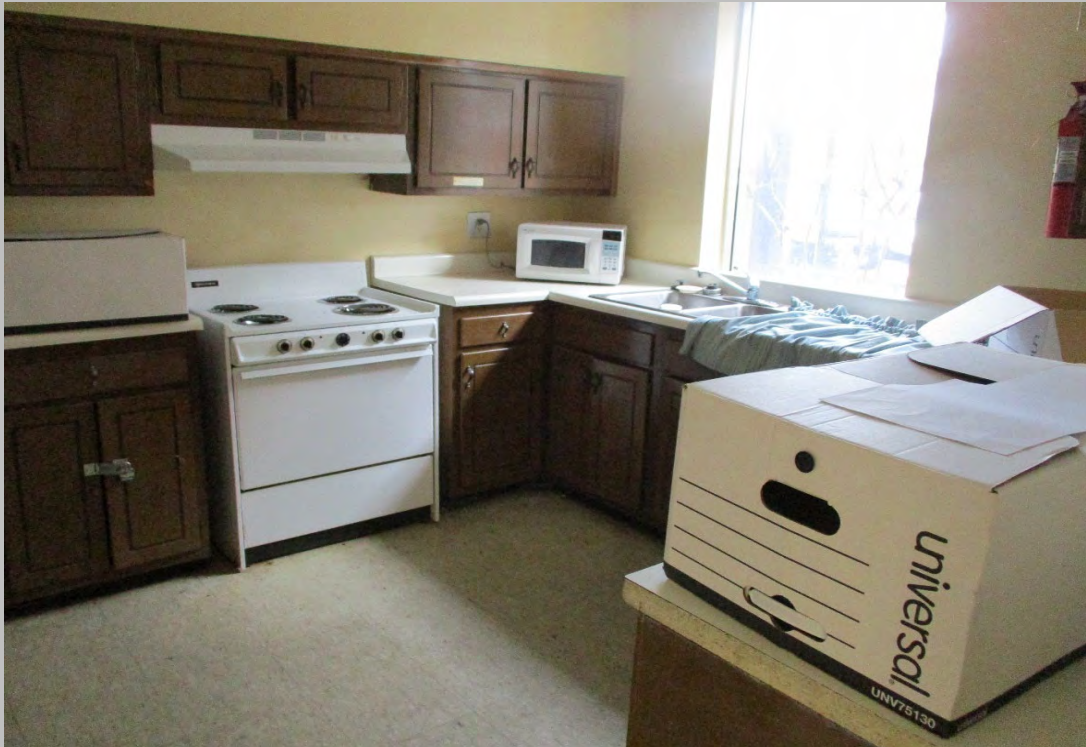
PHOTO #12

View of the community kitchen

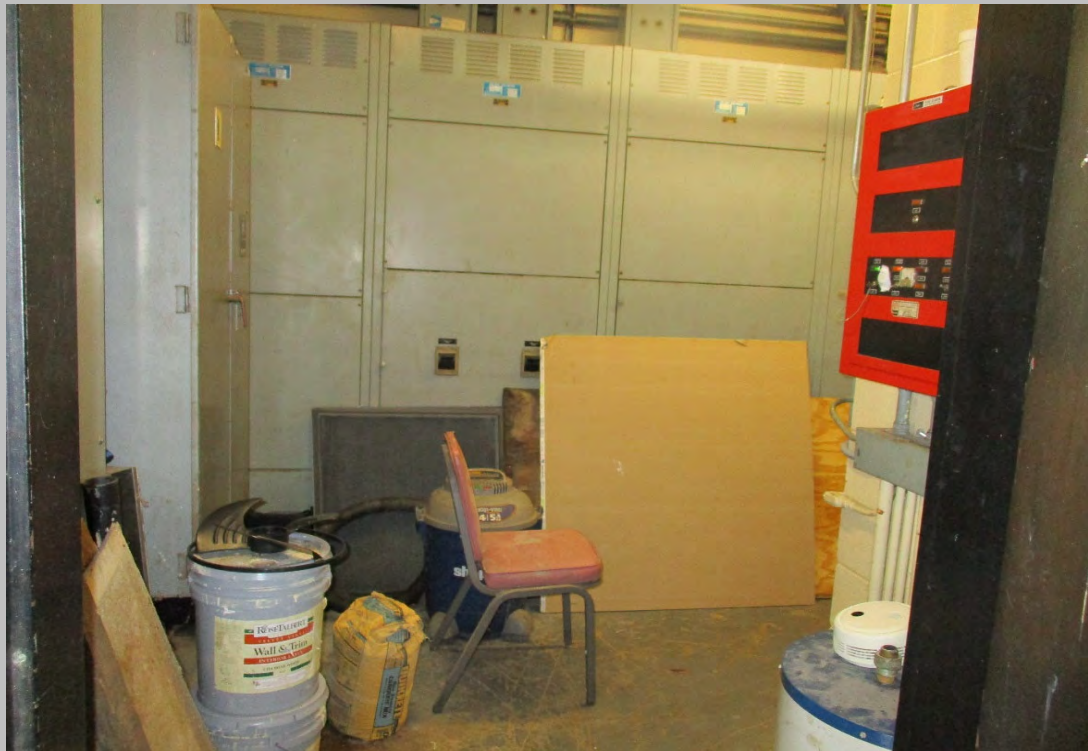
PHOTO #20

View of the electrical equipment area

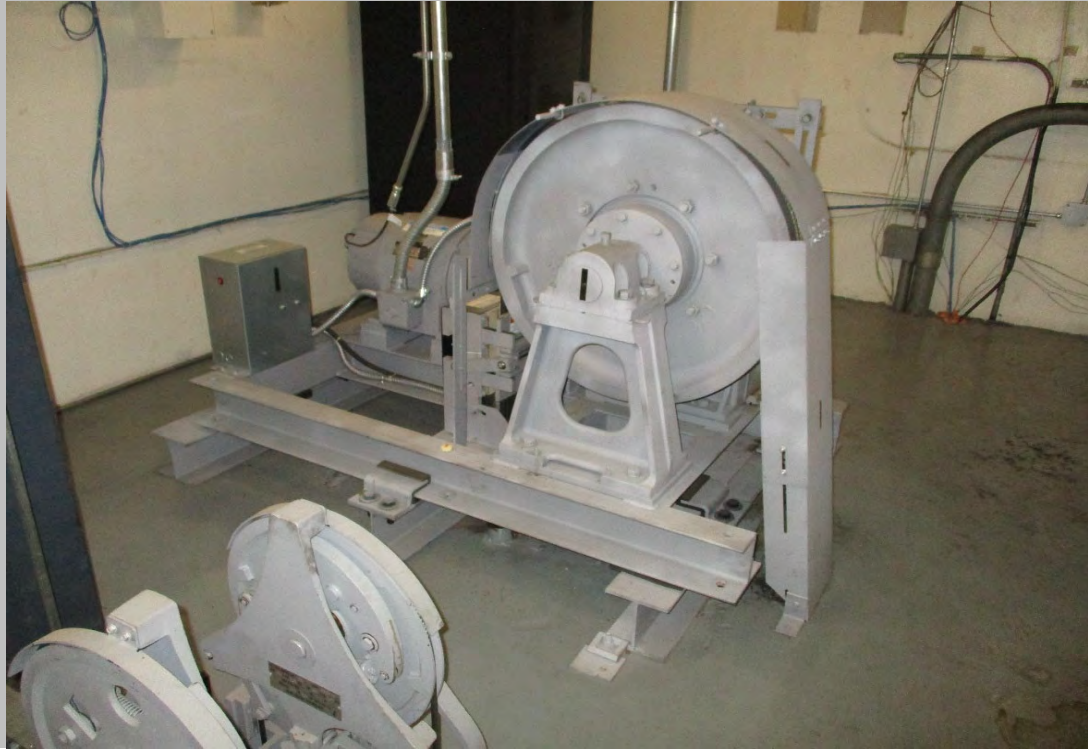
PHOTO #21

View of typical elevator equipment

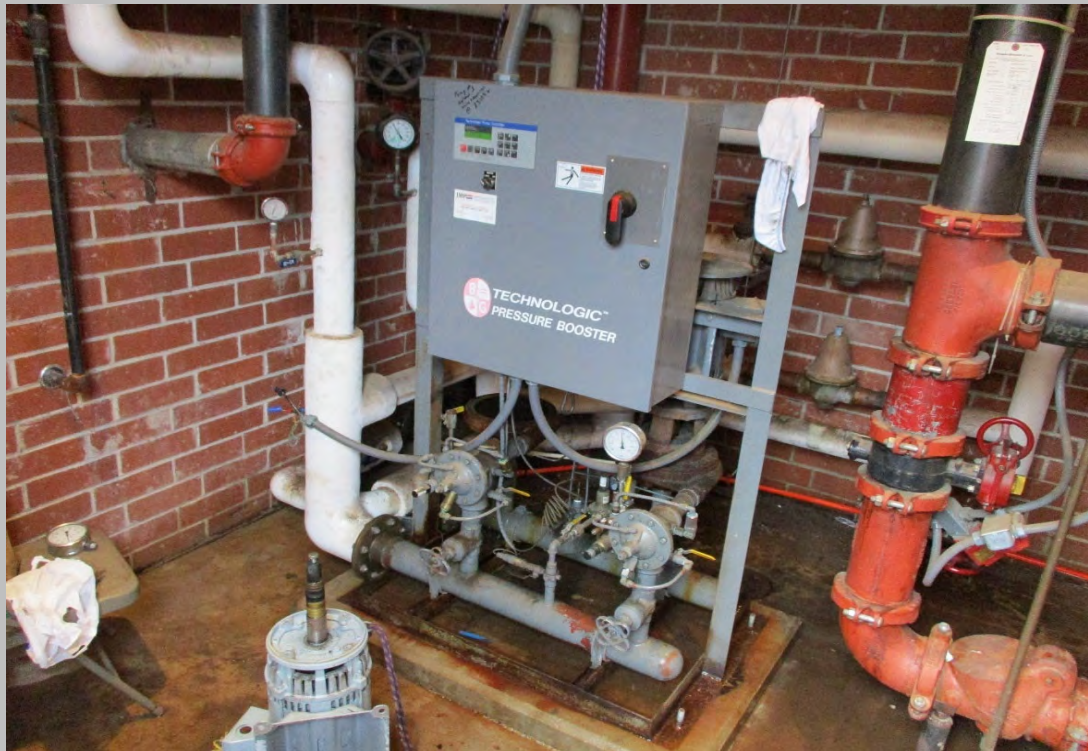
PHOTO #22

View of the pump house equipment at the subject property

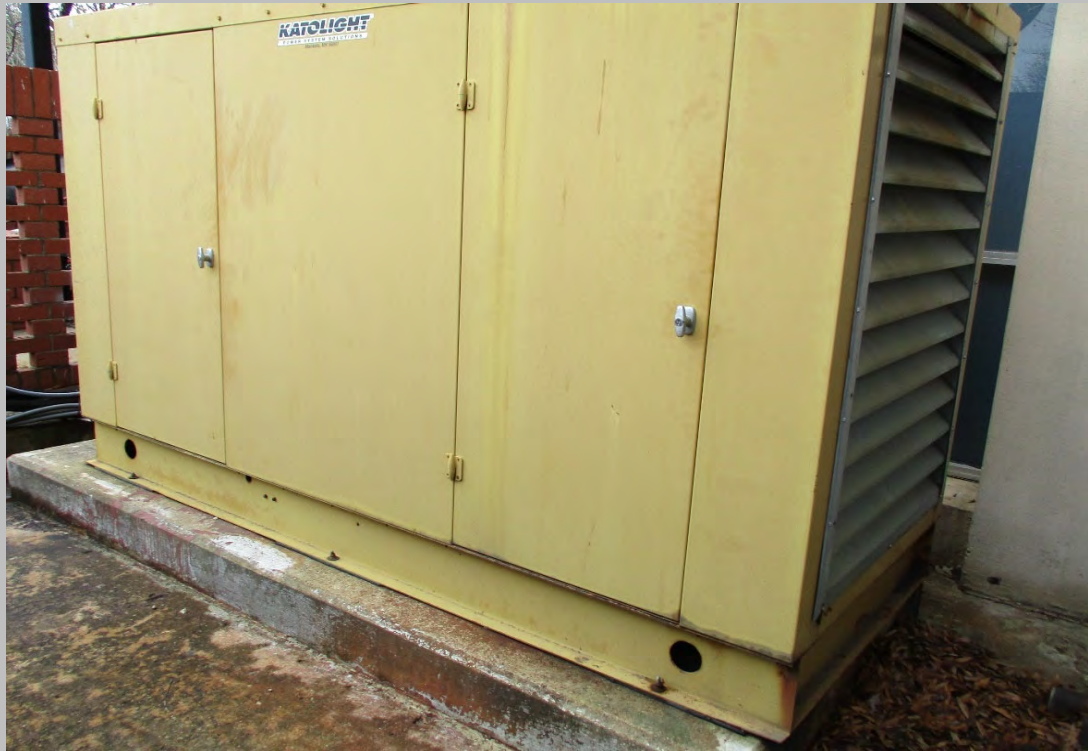
PHOTO #23

View of the natural gas generator at the subject property

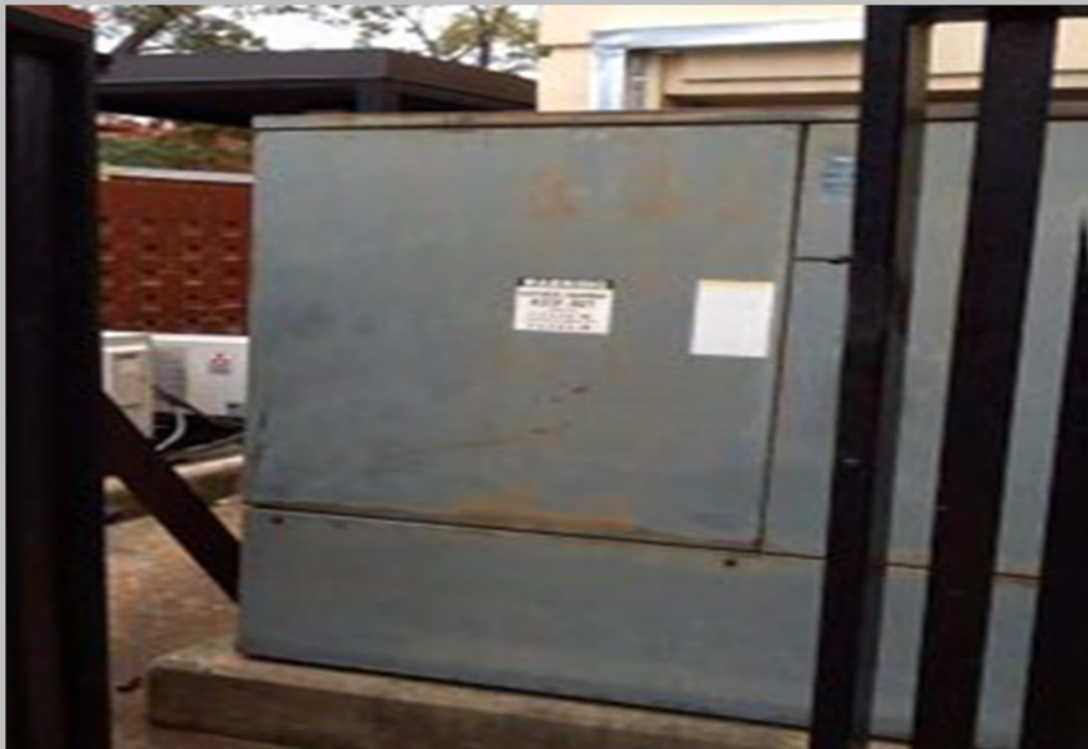
PHOTO #24

View of the pad-mounted electrical transformer at the subject property

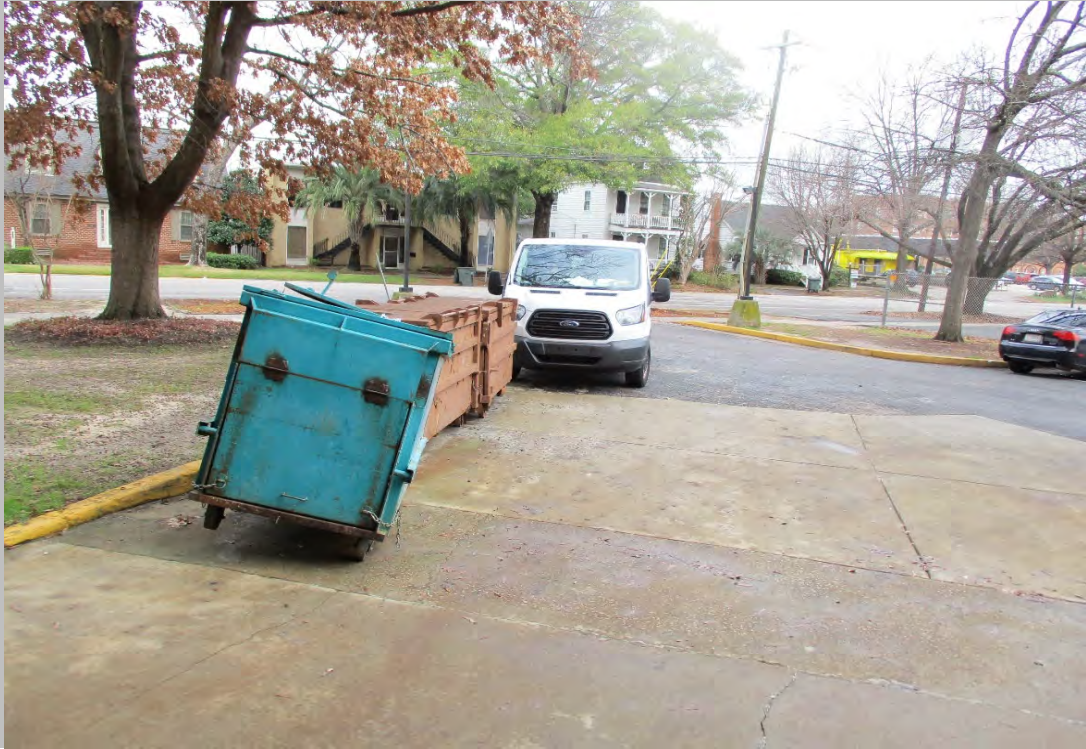
PHOTO #25

View of typical solid waste dumpsters at the subject property

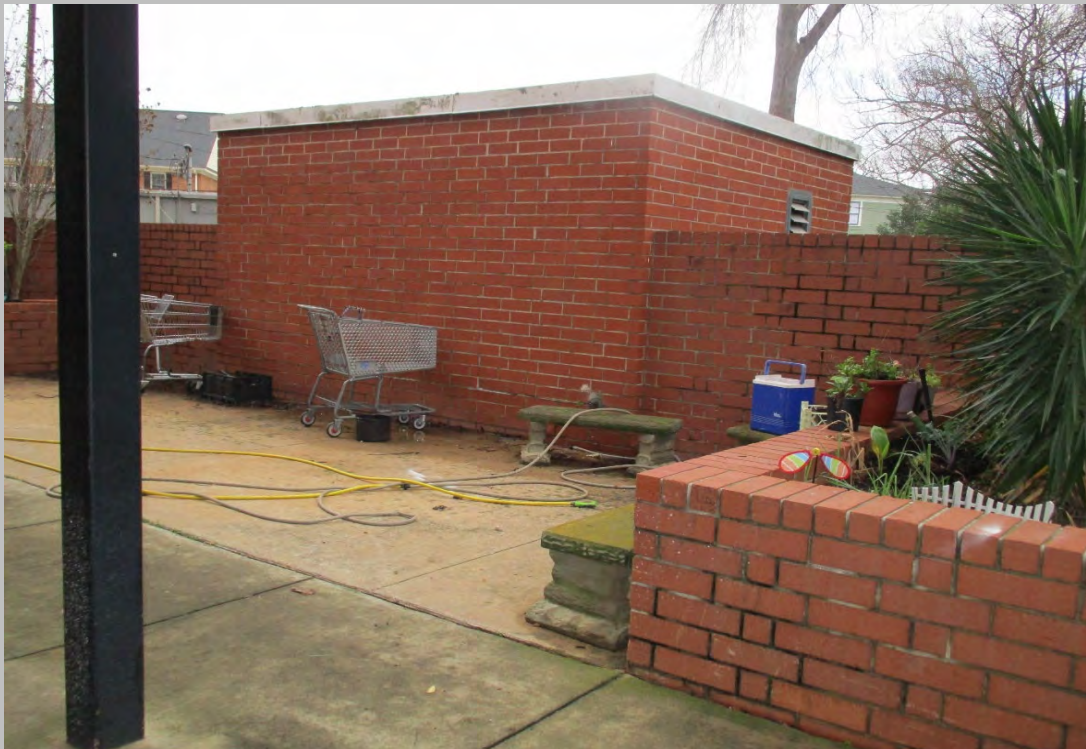
PHOTO #26

View of the patio at the subject property

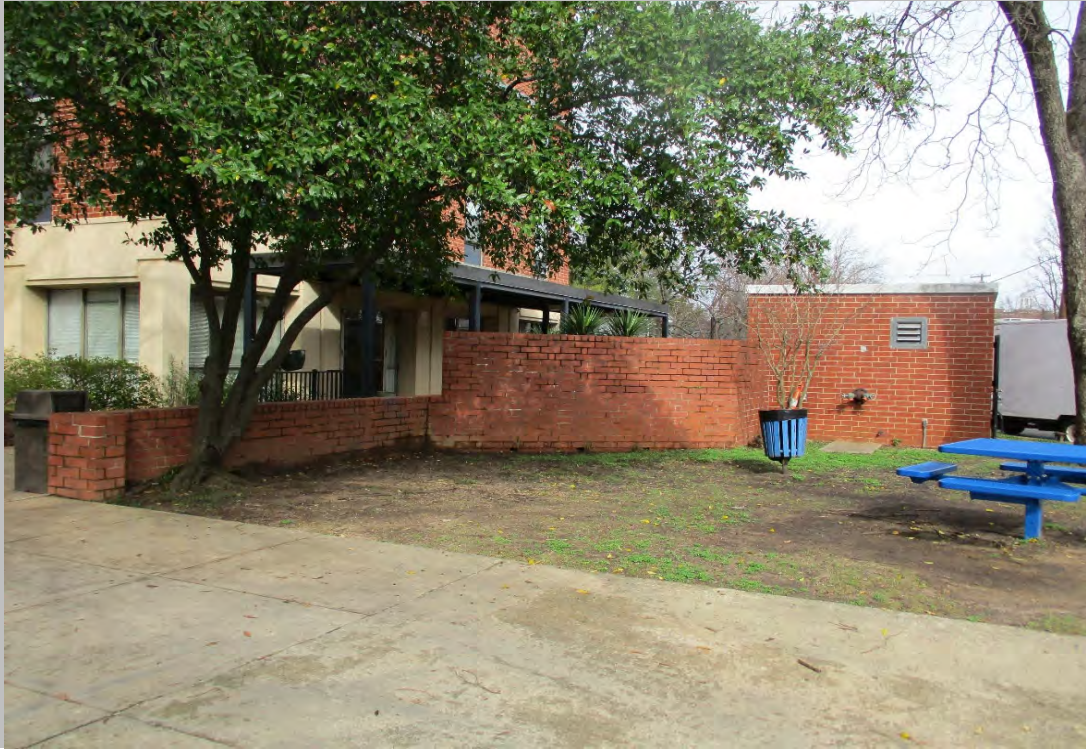
PHOTO #27

View of the picnic area at the subject property
