REQUEST FOR PROPOSALS

MARION STREET HIGHRISE

Property: Marion Street High Rise
1930 Marion Street
Columbia, South Carolina 29201

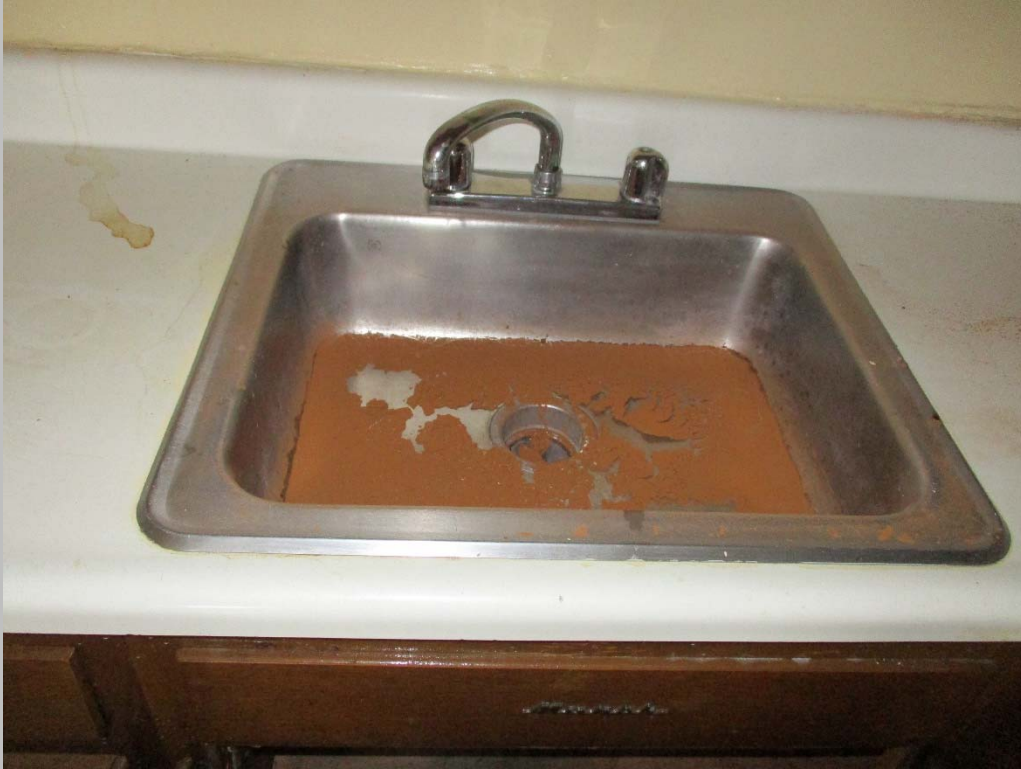
PHOTO #37

Dwelling unit sinks experience frequent backups throughout

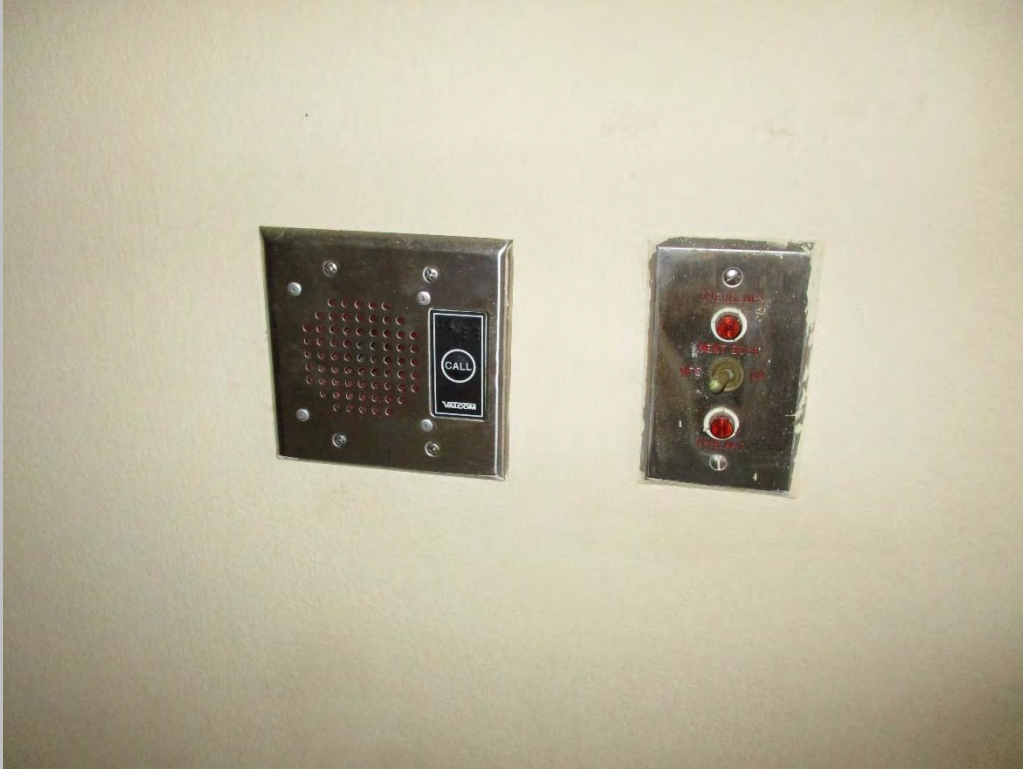
PHOTO #49

Typical non-compliant emergency call unit

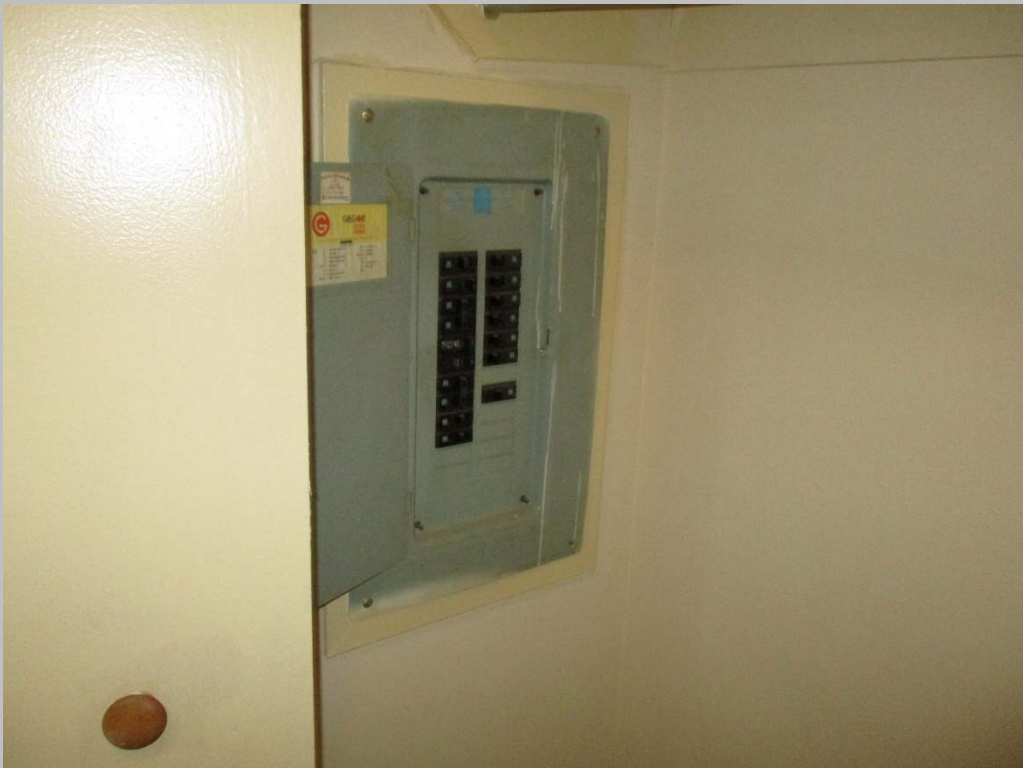
PHOTO #50

Electrical panels installed in closets throughout

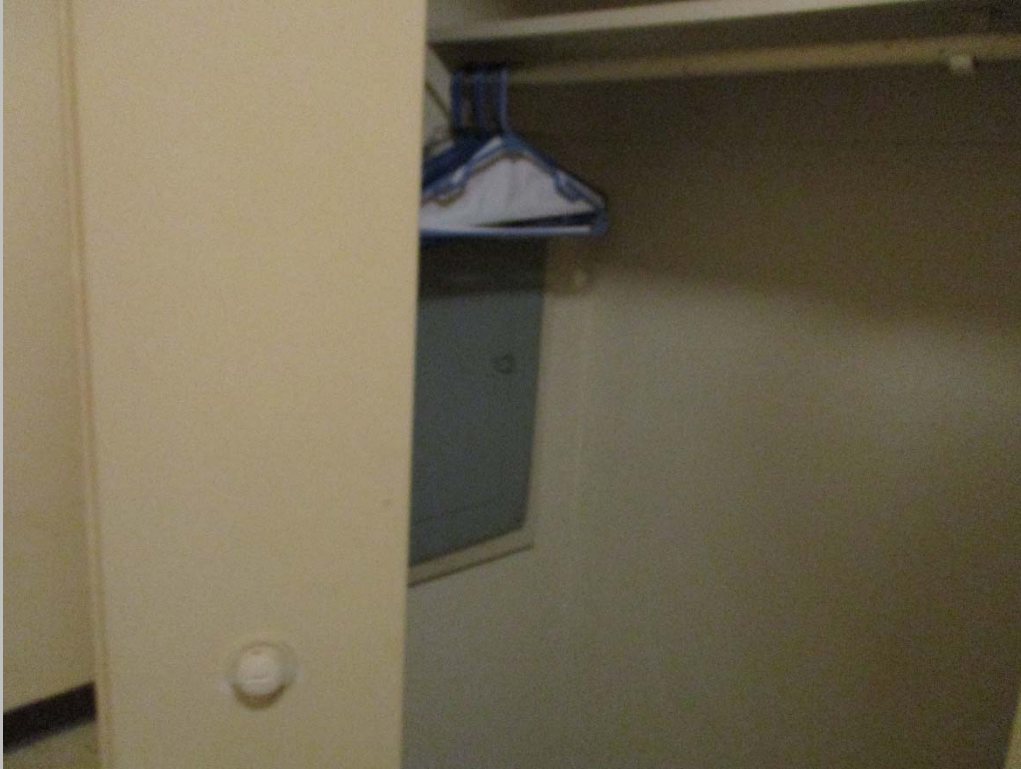
PHOTO #51

Electrical panels installed in closets throughout
