**PHASE I
ENVIRONMENTAL SITE ASSESSMENT
MARION STREET HIGHRISE
1930 MARION STREET
COLUMBIA, RICHLAND COUNTY, SOUTH CAROLINA**

**D3G PROJECT NUMBER:
2020 - 0581**

**FINAL REPORT ISSUE DATE:
JULY 23, 2020**

**INSPECTION DATE:
JANUARY 14, 2020**

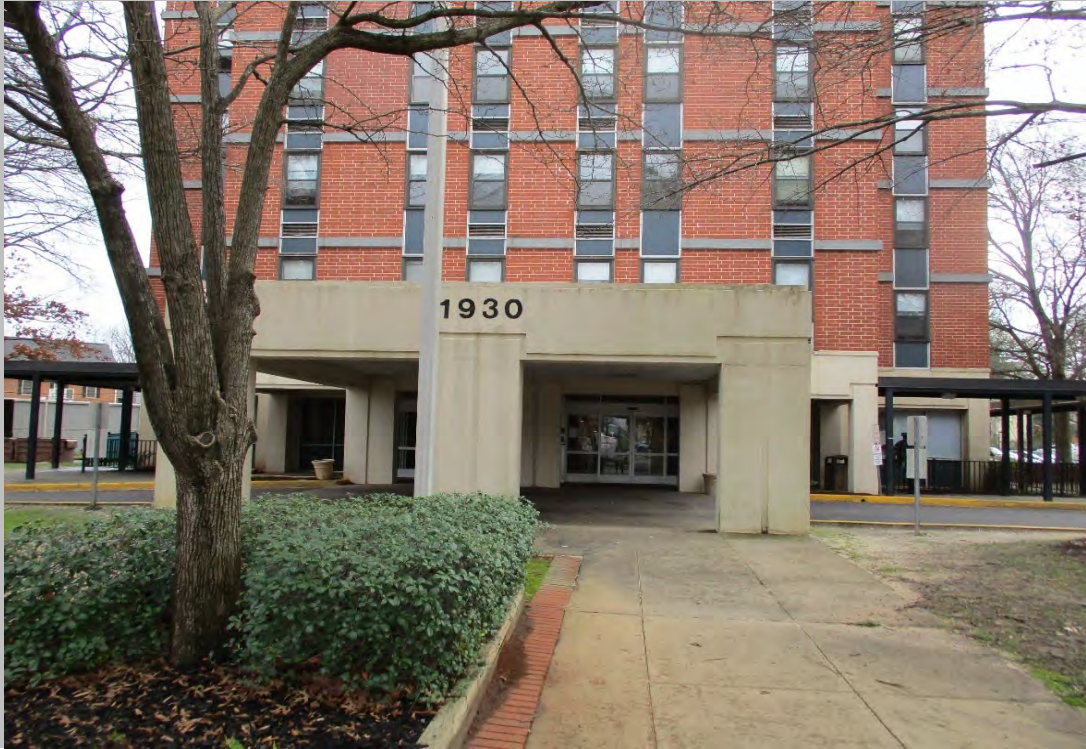
PHOTO #1

View of the subject property

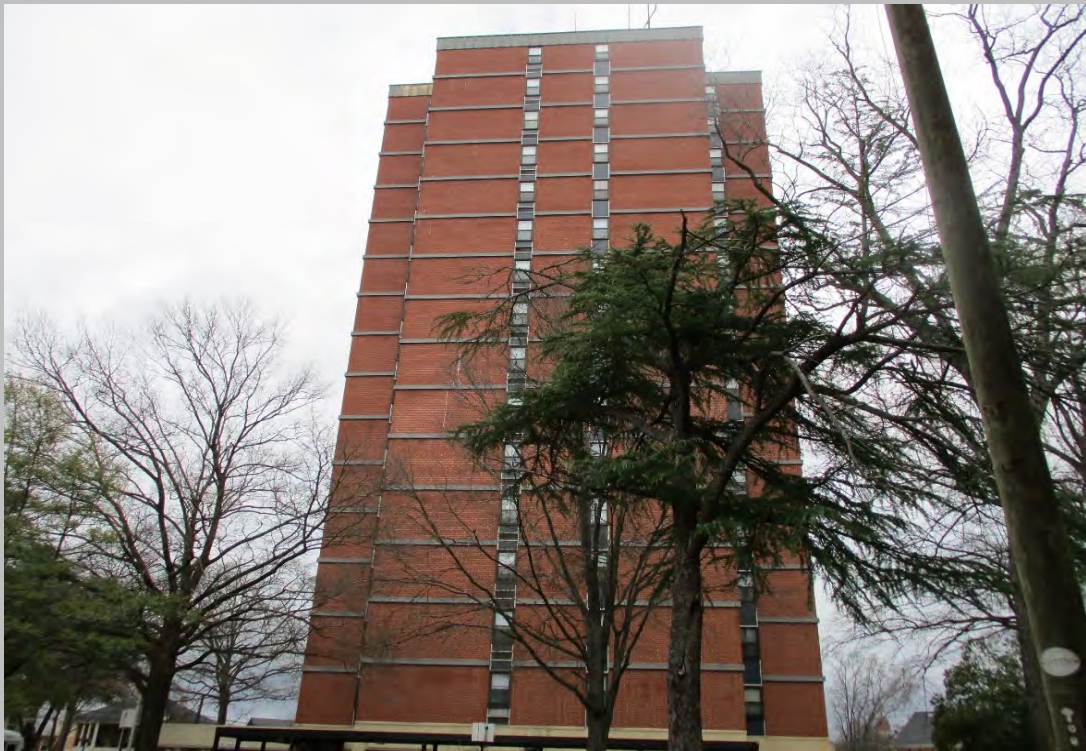
PHOTO #2

View of the subject property

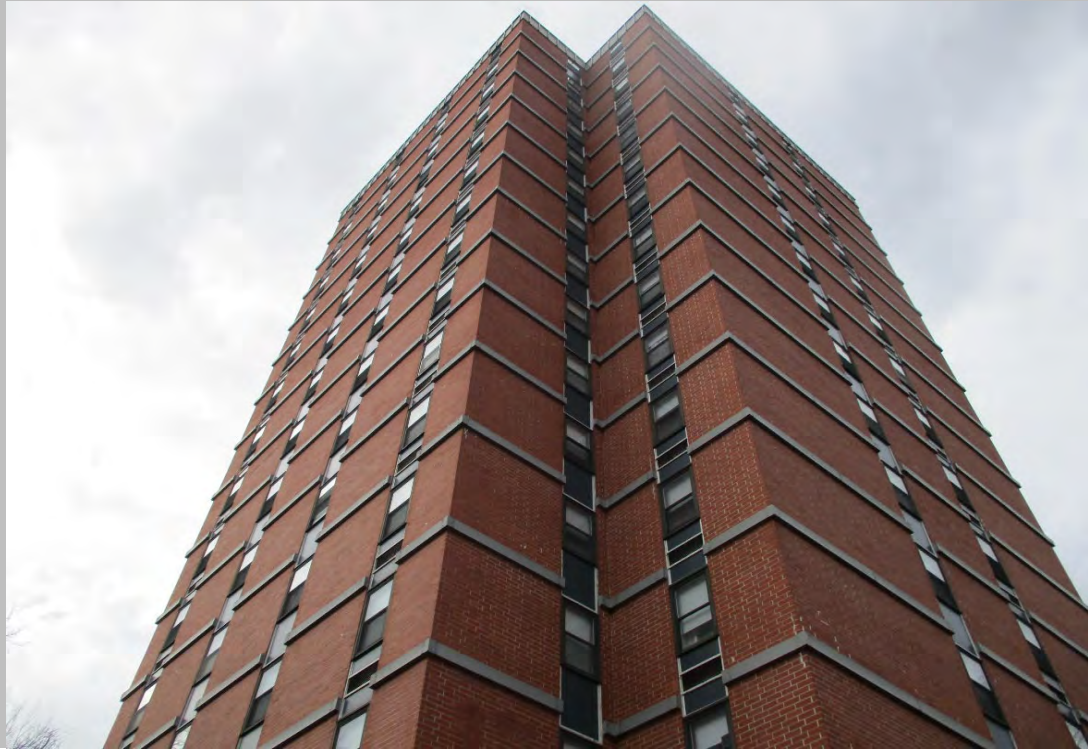
PHOTO #3

View of the subject property

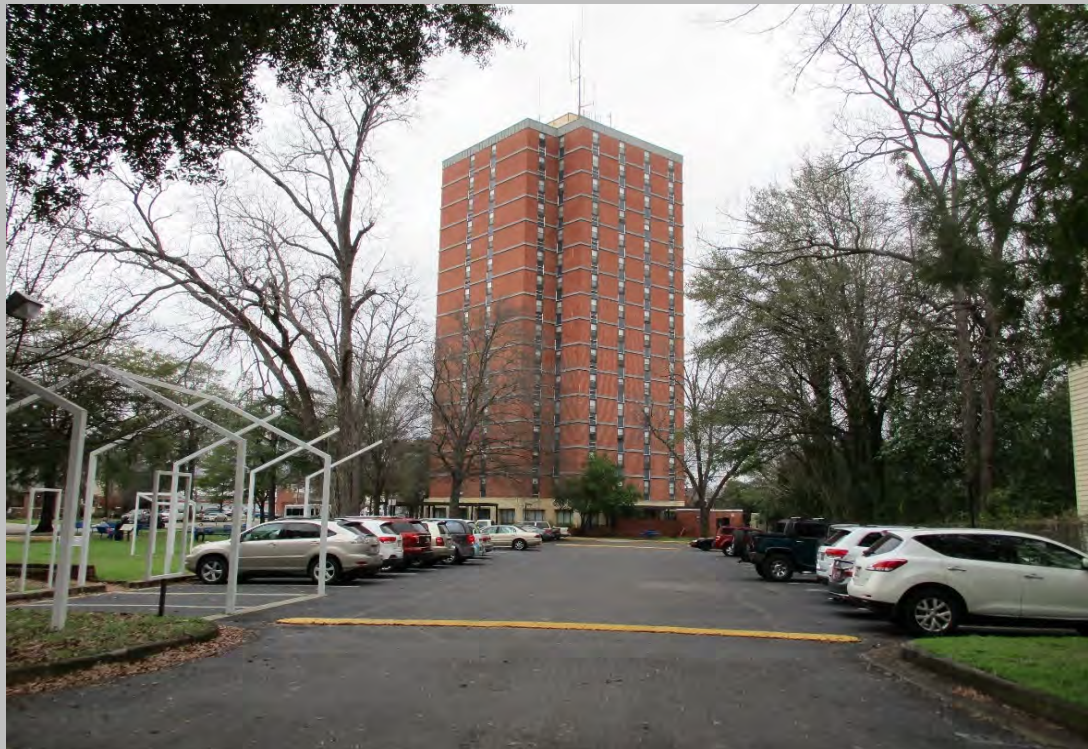
PHOTO #4

View of the subject property

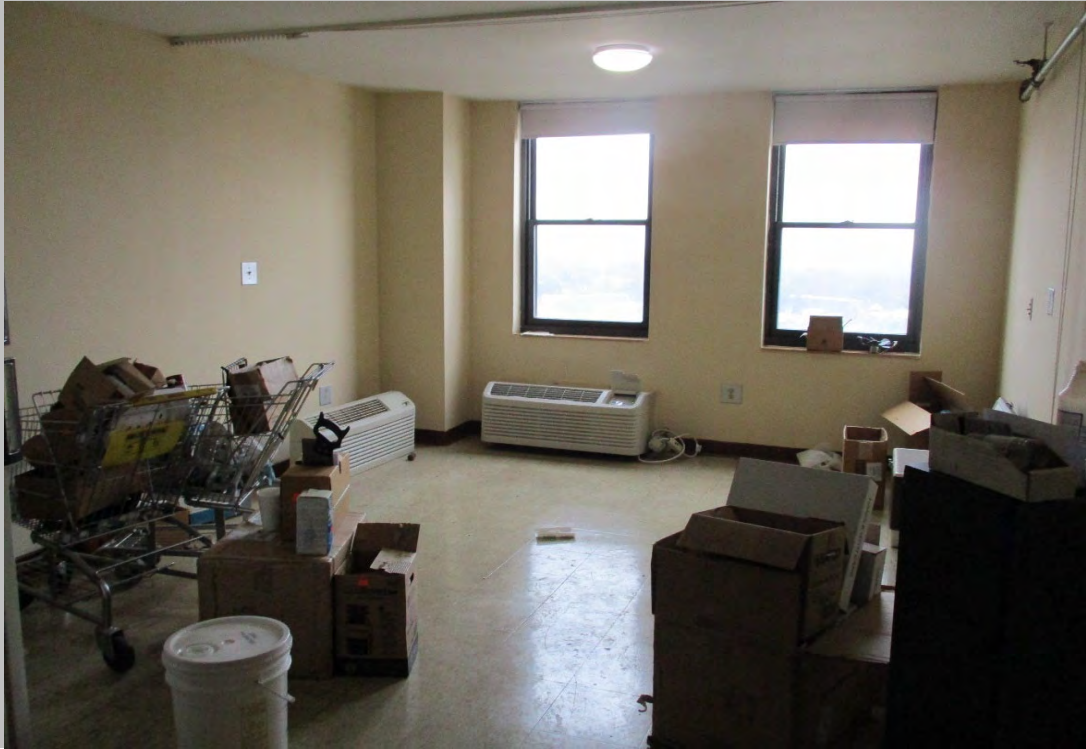
PHOTO #5

View of a typical residential unit living room

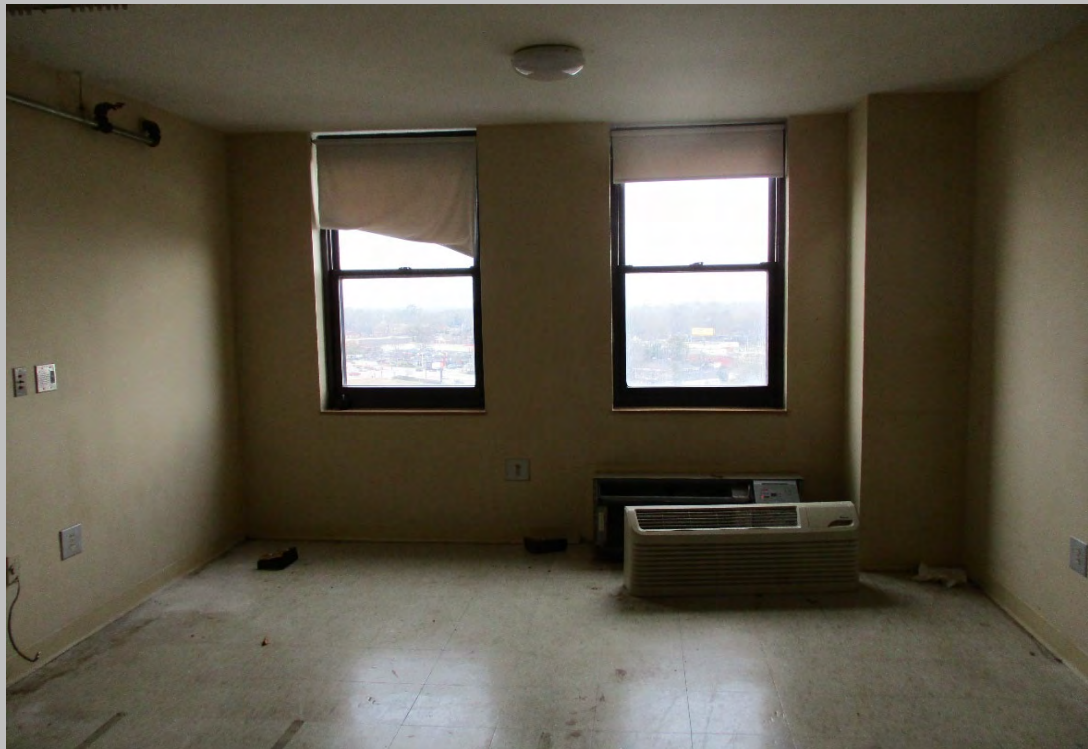
PHOTO #8

View of a typical residential unit bedroom

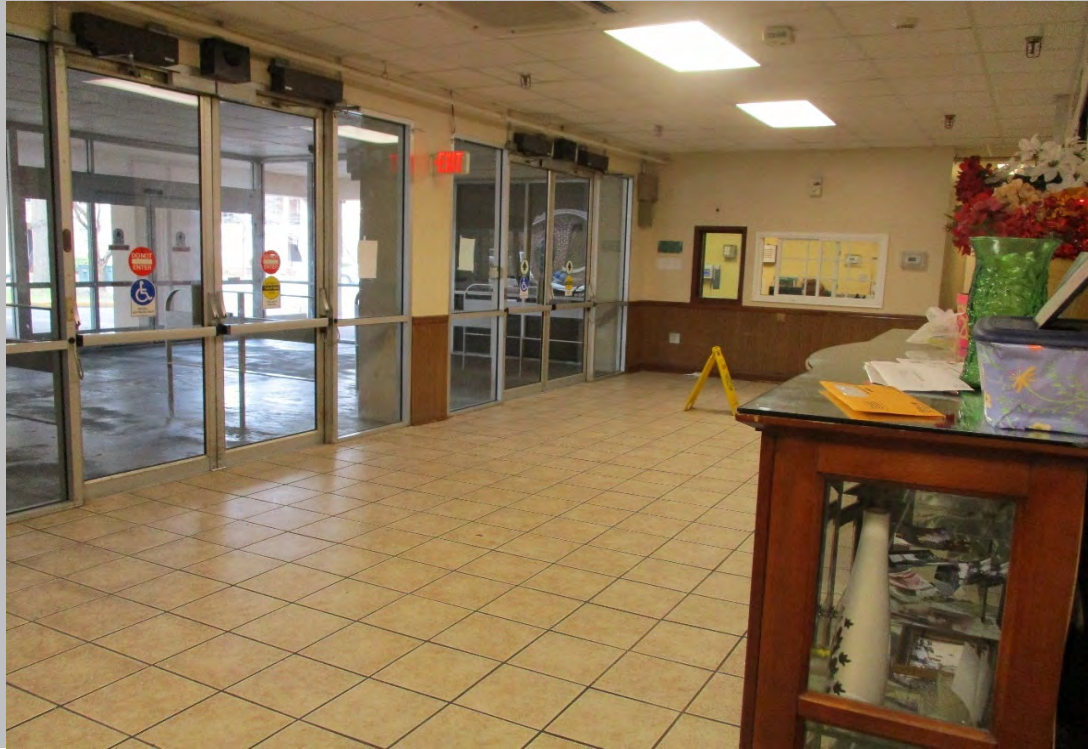
PHOTO #9

View of the lobby

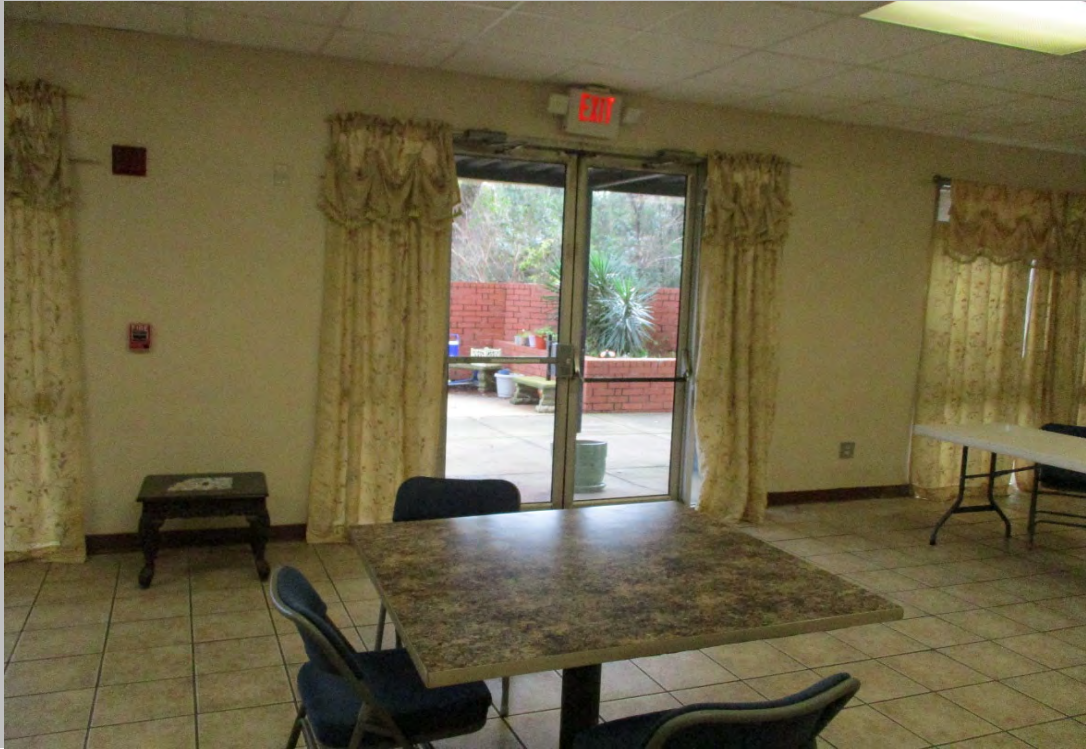
PHOTO #11

View of the community room

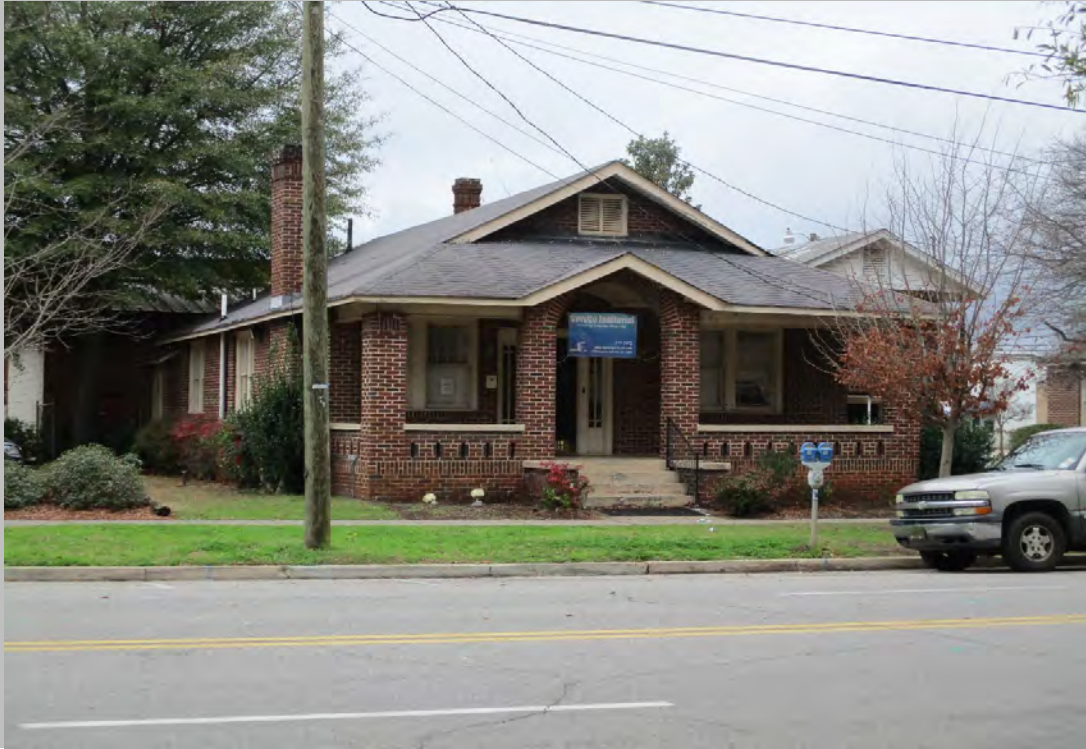
PHOTO #39

View of the western adjacent ServCo Janitorial

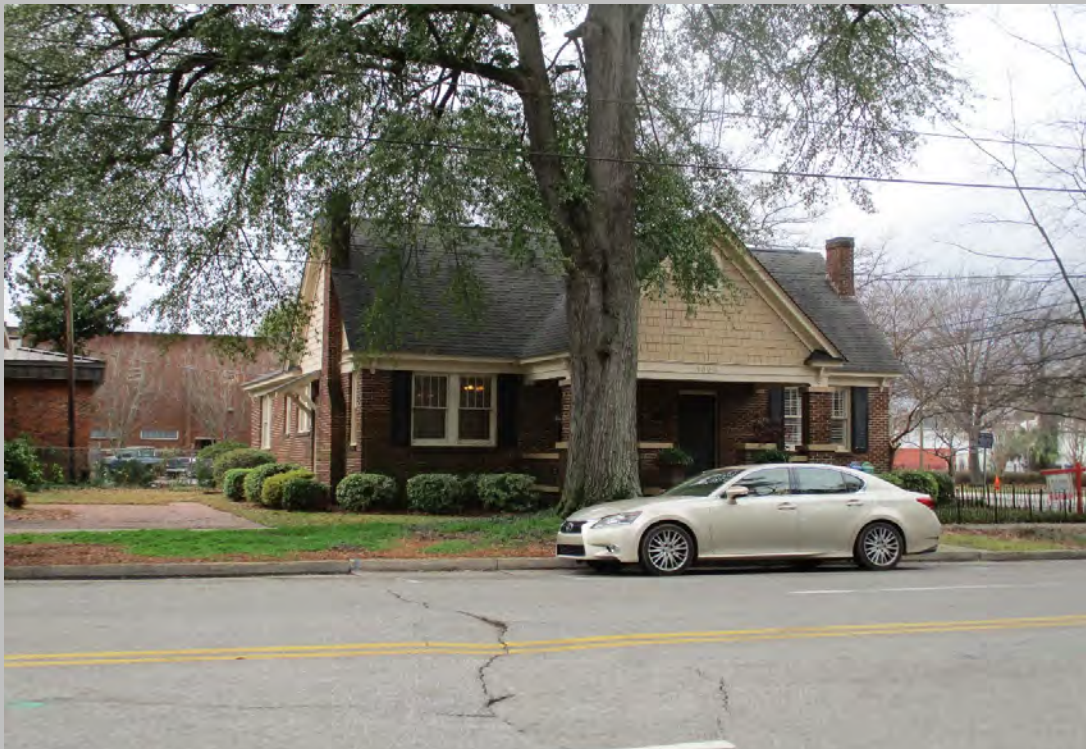
PHOTO #40

View of the western adjacent Foundation Mortgage Corporation
